TMDXEVM6670 EVM Known issues

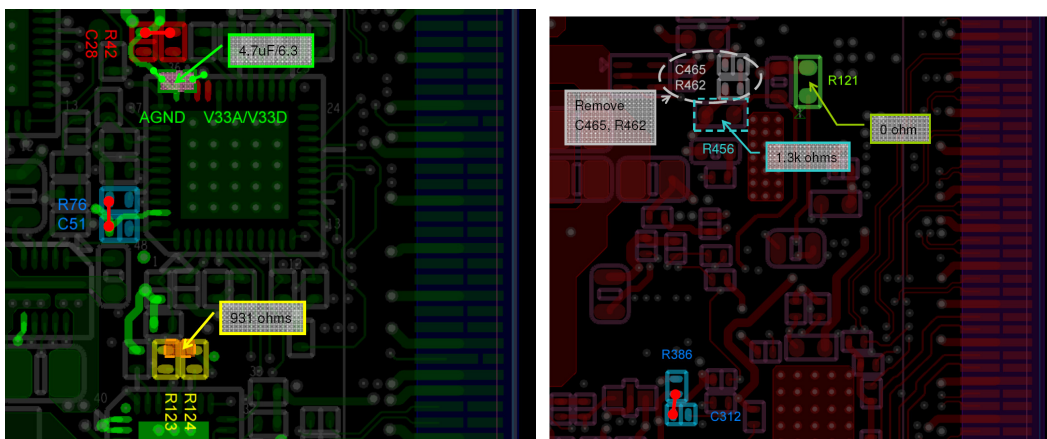
The C6670 Rev 2.0 production EVMs (PCB number is 19C2830201 and the PCB version A102-1) had a power-up problem with the UCD9222, UCD74110 and UCD74106 power solution because of noise caused by UCD74110 grounding return path. The design of the power supplies on CVDD and VCC1V0 (CVDD1) rails need below workarounds to fix the problem. All Rev 2.0 production boards received these corrections prior to shipment.

1. Connecting several AGND (named UCD9222_AGND) and digital ground (GND) points need to be done to reduce the noise on analog ground from the PowerPAD of UCD74110.
 - a) AGND on C28 (AGND pin of UCD9222) and digital GND on R42 (topside of the PCB)
 - b) AGND on C51 (AGND pin of UCD9222) and digital GND on R76 (topside of the PCB)
 - c) AGND on C312 (CS1 pin of UCD9222 for sensing UCD74110 current) and digital GND on R386 (backside of the PCB)

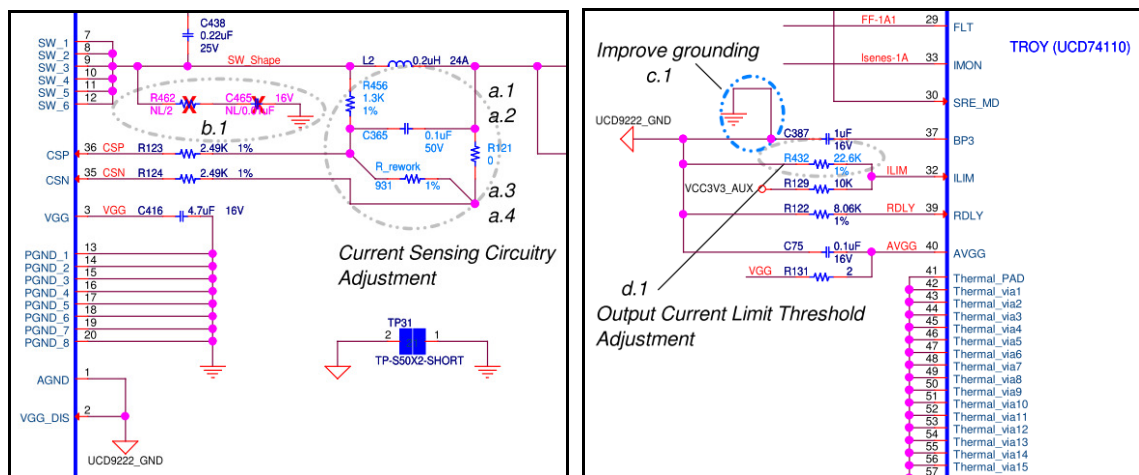
2. The current sensing circuitry on UCD74110 was changed to match the DCR of the output inductor. This was required for proper current monitoring of the UCD74110 by the UCD9222.

- a) Modify R456 to 1.3k-ohm, C365 to 0.1uF, R121 to 0-ohm, and additional 931-ohm across the ends of R123 and R124 near C365 and R121 side for the correct current sensing;
- b) Modify R432 to 22.6k-ohm for current limitation;
- c) Remove R462 and C465.

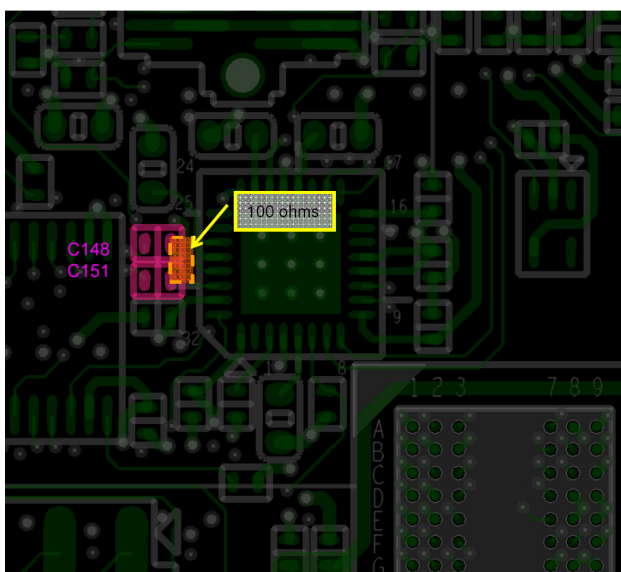
The C6670 Rev2.0 production EVMs require a termination resistor across the reference clock input of the CDCE62002. Lack of the termination allowed noise to be coupled onto the differential clock signal which prevented the PLL from locking robustly. This LVPECL clock signal should have a 100-ohm termination but it was omitted in the design.

The ECN is adding a 100-ohm resistor across the ends of C148 and C151 nearby the input of CDCE62002 to reduce the noise. It makes the output clock stable and PLL robustly locked.

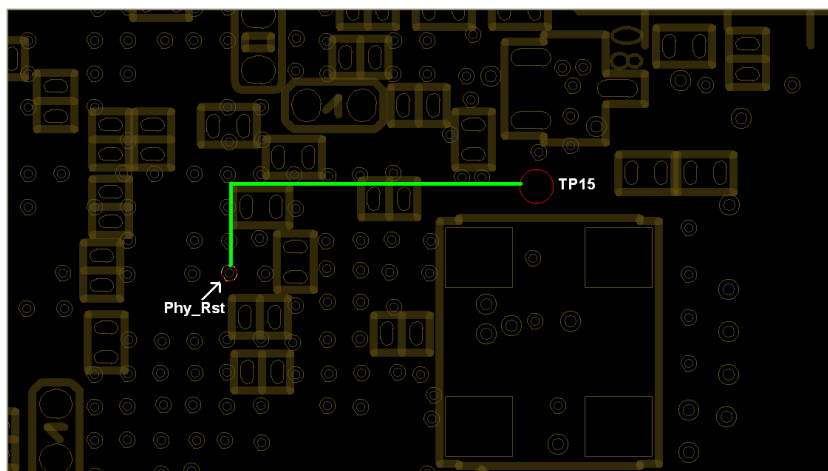
The Beta1 and Beta2 EVMs of C6670 were corrected before shipment. The RESET# (PHY_RST#) signal of 88E1111, the PHY of Gigabit Ethernet, was driven by an input pin K11 of FPGA instead output, it makes the PHY stay in reset state. The workaround is connecting the PHY_RST# to the TP15 pad of FPGA to fix the problem. The below figure shows the rework done on the PCB backside of Beta1 and Beta2 EVMs.

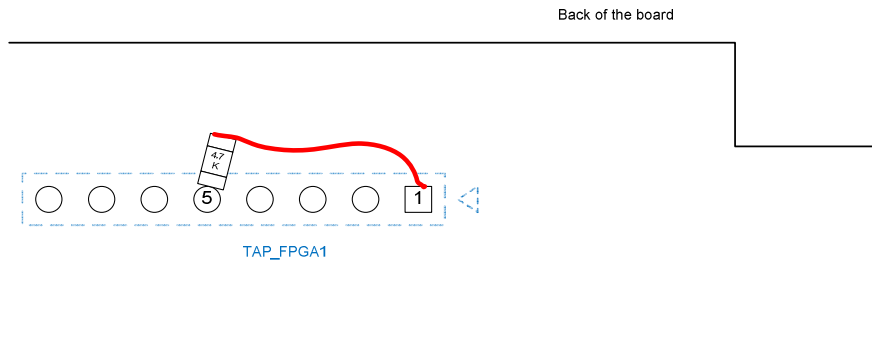
All Beta1 and Beta2 EVMs have a design erratum that may need to be corrected. Beta2 EVMs received this ECN before they were shipped from the factory. The TDI input to the FPGA is floating. This has been observed to allow unexpected FPGA behavior on a small percentage of the boards. Often the SYSPG_D1 LED goes out and CCS unexpectedly disconnects. A pull-up resistor needs to be added to prevent this from happening. This can be added on the bottom of connector TAP_FPGA1 between pins 1 and 5. Any resistor value between 1K and 10K will suffice. The following figure shows this rework.

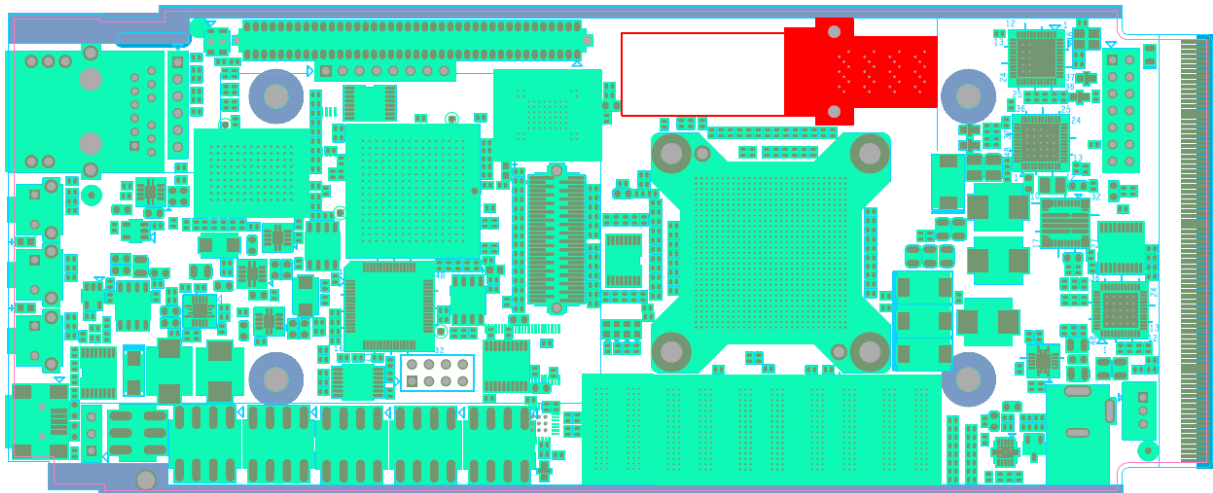
All Beta1 and Beta2 EVMs had populated the iPass+HD mini-SAS connector on the HyperLink1 for the HyperLink connection. The pin out on the HyperLink1 is incorrect. Many signals will be shorted if connecting the HyperLink interface by the cable. The HyperLink1 can NOT be used and should be removed on Beta1 EVMs. The HyperLink connectors were removed from Beta2 EVMs before they were shipped from the factory.
