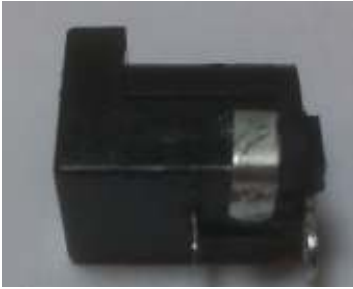
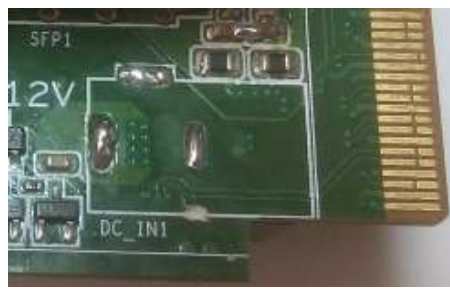
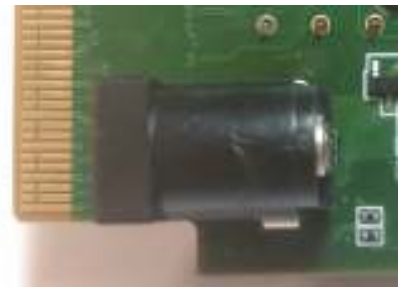
1. Fold the middle pin of power jack and move the power jack to backside to avoid the interference with AMC golden finger

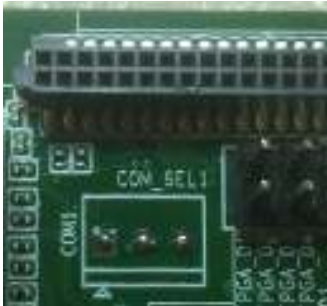
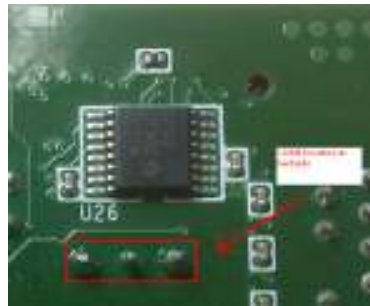
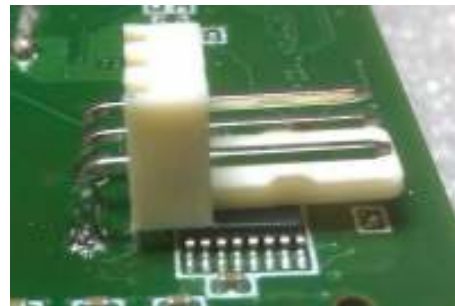
2. Move the COM1 to backside and adopt a 90 degree connector to avoid the interference with XDS560V2 mezzanine card.

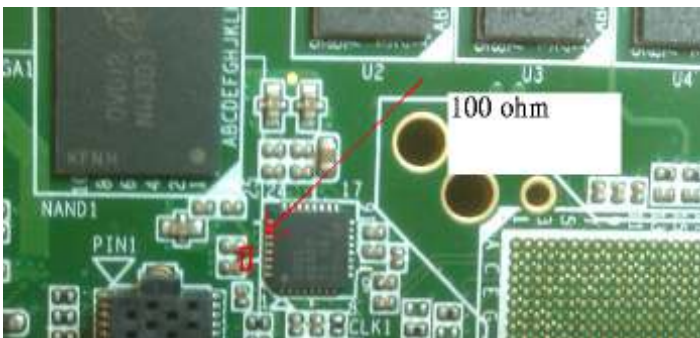
3. The CDCE62002 do not have built in 100-ohm terminations, so add a 100-ohm resistor across the CLK1 sides of the C46 and C51 for REFCKP/N inputs to CLK1 (DDR3 reference clock)

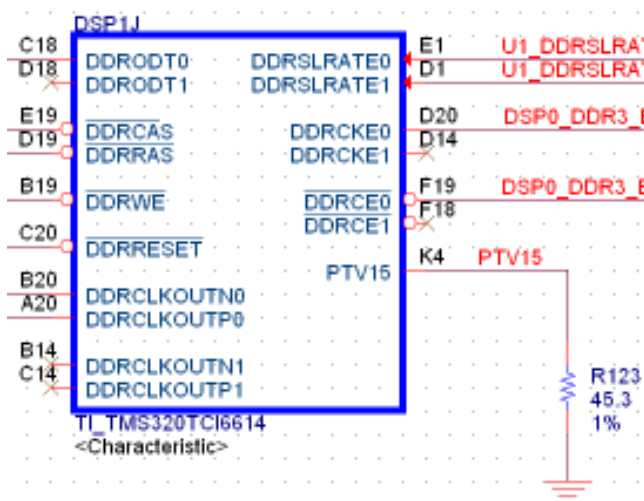
4. Change the value of R123 to 45.3 ohm

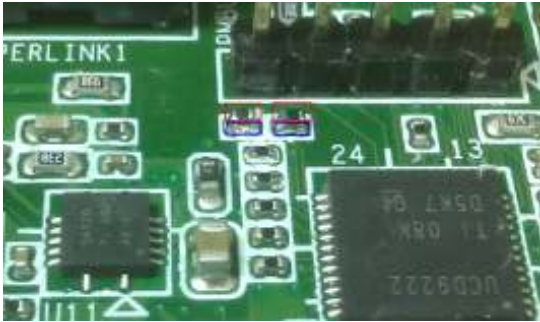
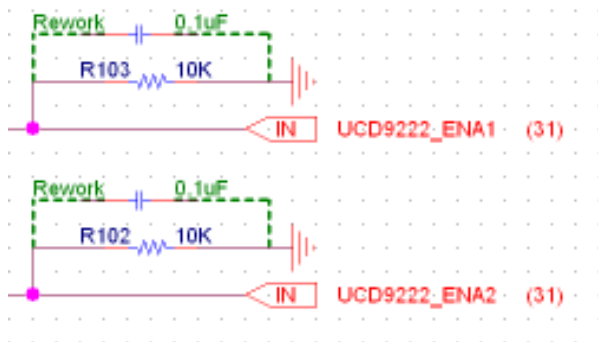
- Due to the UCD74106 unstable issue, parallel the 0.1uF capacitor at R102 and R103 to filter the noise on UCD9222_ENA1 and UCD9222_ENA2

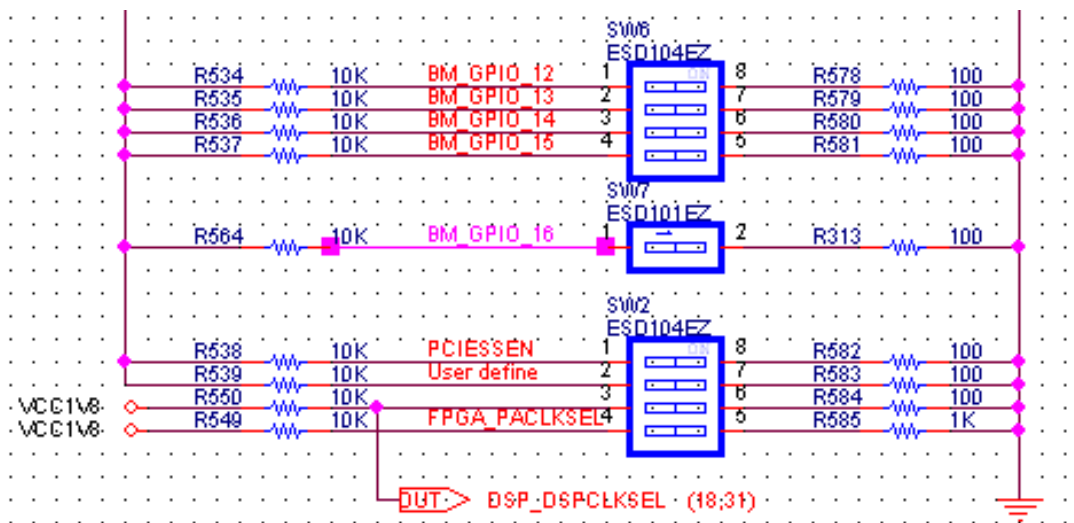
- BM_GPIO_16 is not connected to FPGA, and so we make a workaround on FPGA code to control GPIO16 with SW2(user define pin)

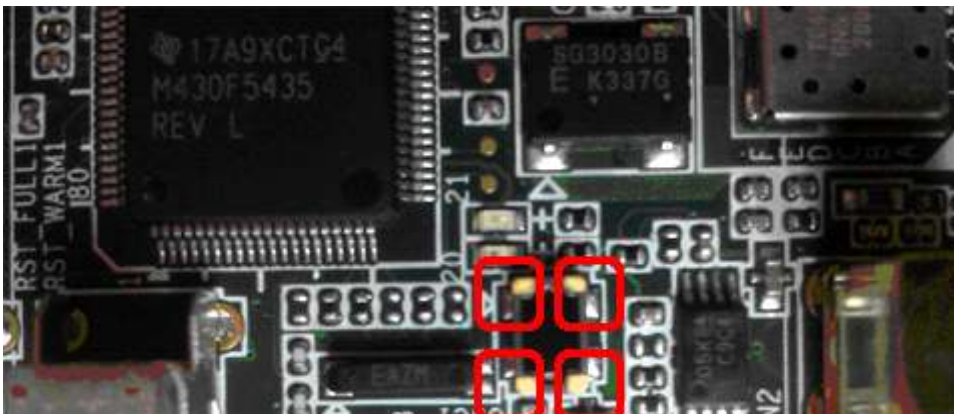
- The footprint of OSC1(VCTCXO) are too small to assembly on PCB. We will measure the clock signal after SMT to assure the functionality.
