EVMK2HX Known Issues

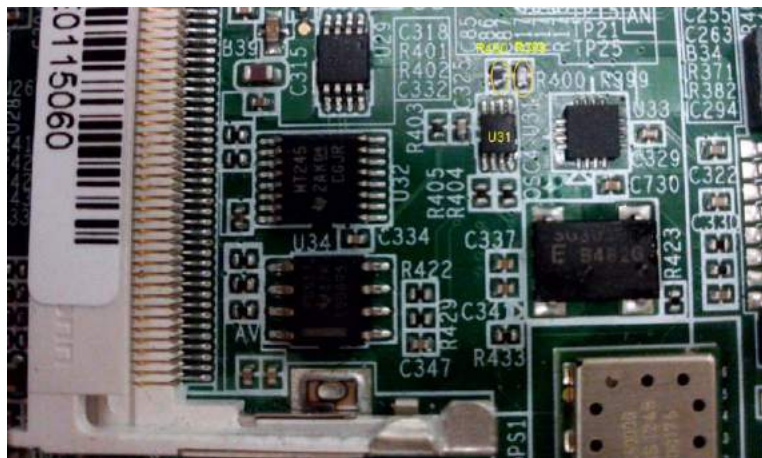
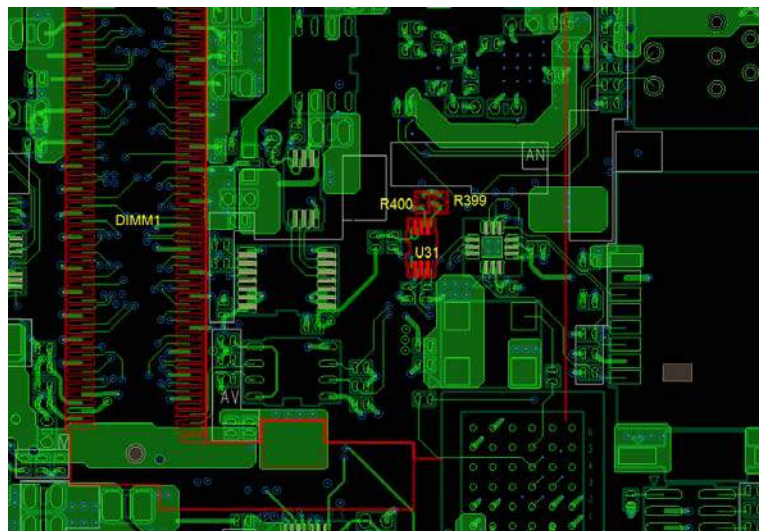
2.1 EMAC Link Down Issue

- Description: Noise on MDCLK signal impacts stability of the MDIO link. When Linux kernel sees MDIO link go down it tears down data link as well. Have not seen an issue with using MDIO link to configure external PHY.
- Workaround: Different options under investigation.
 1. Modify code not to depend upon MDIO link remaining active for EMAC communication
 2. Add stronger pull-up resistors on MDCLK and MDIO signal, by replacing R399/R400 from 4.7 kohm with 220 ohm resistors (0402 sized)

- Plans for a fix: Will clean up routing of MDCLK signal on Rev2.0. BOM will also be changed on future builds to incorporate 220ohm resistor pull-up changes.

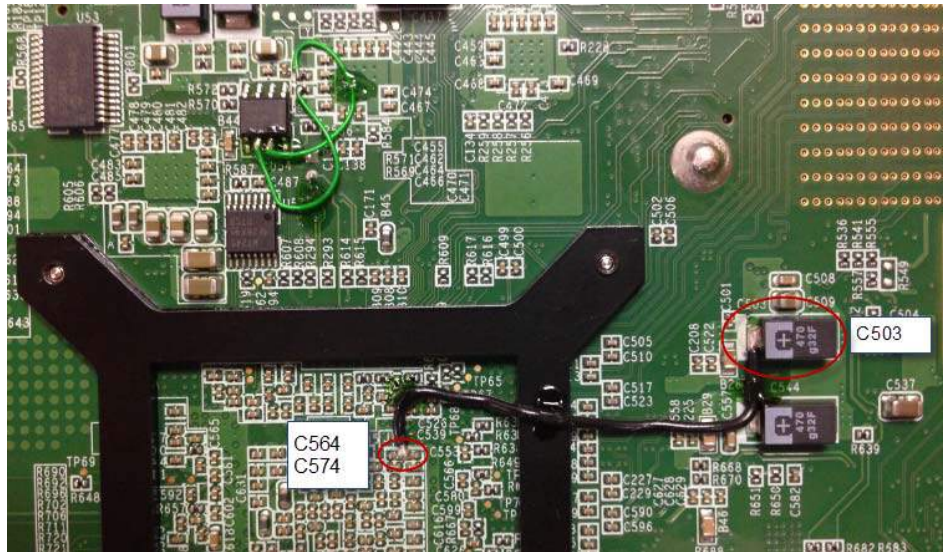
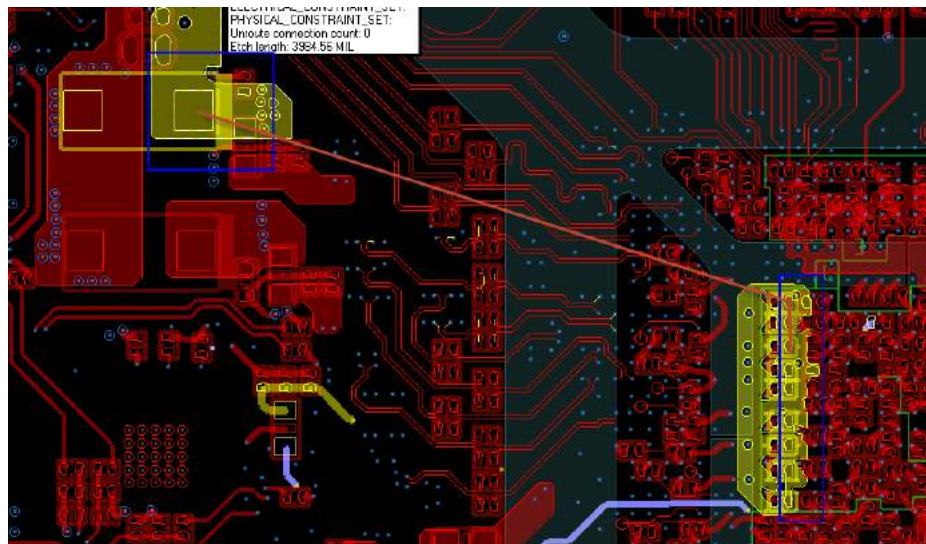
2.2 VCC0V85 Voltage Drop Issue

- **Description:** The trace width of the VCC085 signal is too narrow and causes a voltage drop at the pin of the SOC. Since this supply is used for SerDes interfaces it could cause SerDes interfaces to lose link. This issue has only been identified and observed on the SGMII.
- **Workaround:** A couple different options are still under investigation for their effectiveness.
 1. Add external wire to provided adequate patch for expected current from pin 1 of “C503” (net VCC0V85) to pin 1 of “C564, C574” (net VDD0V85). (Wire length = 5 cm)

Note: That the rework should not link to GND and cause short circuit.

- Plans for a fix: The trace width will be fixed on Rev2.0. The filter element on AVDDALV requires an increased current capacity (suggest up to 4A) to allow for margin on worse-case power as per latest Snowbush power estimates when all SERDES are active. Increase of current capacity on filtering elements for AVDDAHV also recommended (suggest up to 3A). Please see latest estimates below. CVDD power budgeted already on the DSP AVS supply. Both of these nets shall be implemented as copper pours up to the filters and as a plane afterwards to minimize resistance and inductance and maximize plane capacitance.

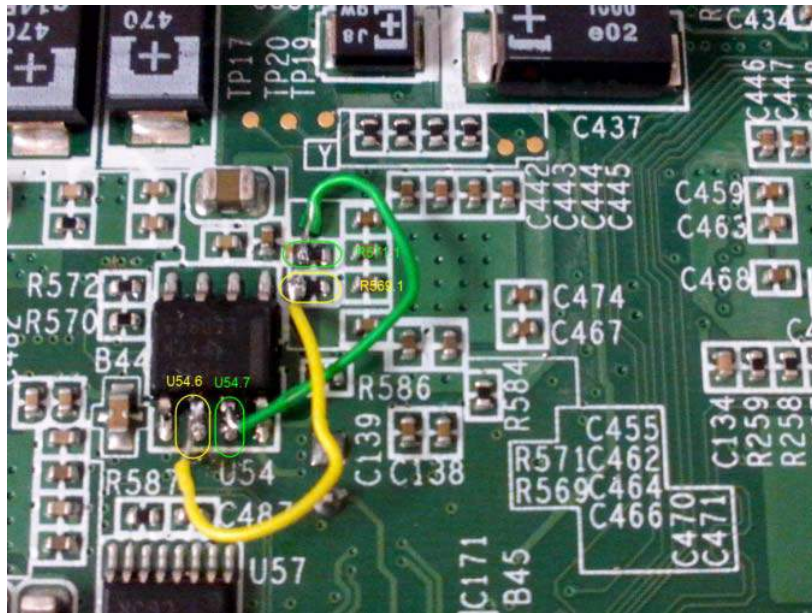
2.3 I2C SDA/SCL Reserve Issue

- Description: SCL and SDA are swapped on U54 bus repeater. Impacts I2C going to 120p Expansion Connector and Zone 3 RTM connector.
- Workaround: Cut the jumper wire (30AWG) to swapped signal of EXP_SDA2_3V3 and EXP_SCL_3V3. Two wire each to similar yellow and green to link from U54.6 to R569.1 and U54.7 to R571.1 .

- Plans for a fix: This will be corrected on Rev2.0.

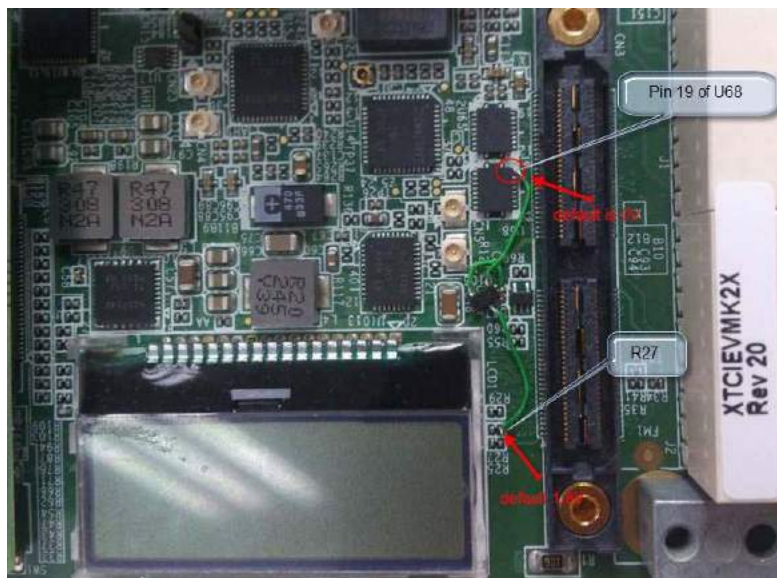
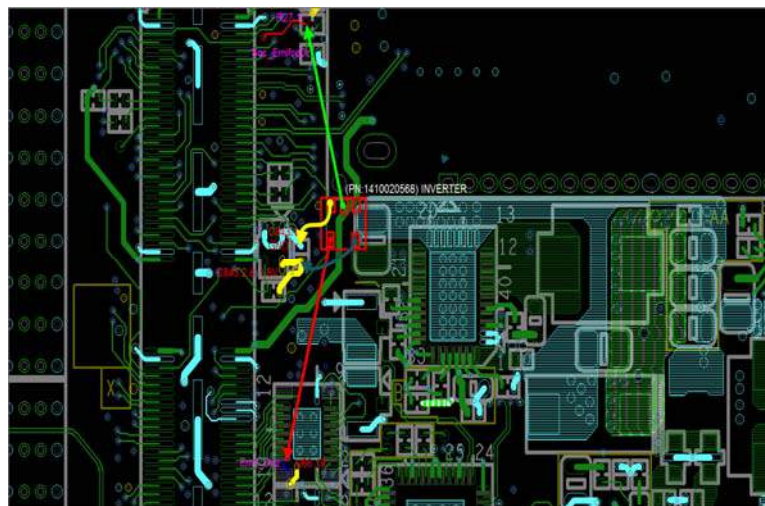
4.1 EMIF and NAND Test cannot be Synchronized

- Description: SoC could not access NAND flash through EMIF interface, and there will be one cause data transmission errors.
- Workaround:
 1. Add inverter (SN74LVC1G04DVR).
 2. Add wire (30AWG) from inverter PIN 3 to C843.1 (GND),
 3. Add wire (30AWG) from inverter PIN 5 to C843.2 (VCC1V8)
 4. Add wire (30AWG) from inverter PIN 2 to R27.1 (SOC_EMIFCE0Z)
 5. Add wire (30AWG) from inverter PIN 4 to U66.19 (EMIF_OEz).

- Plans for a fix: The rework is installed on all Rev 2.0 board before shipping.

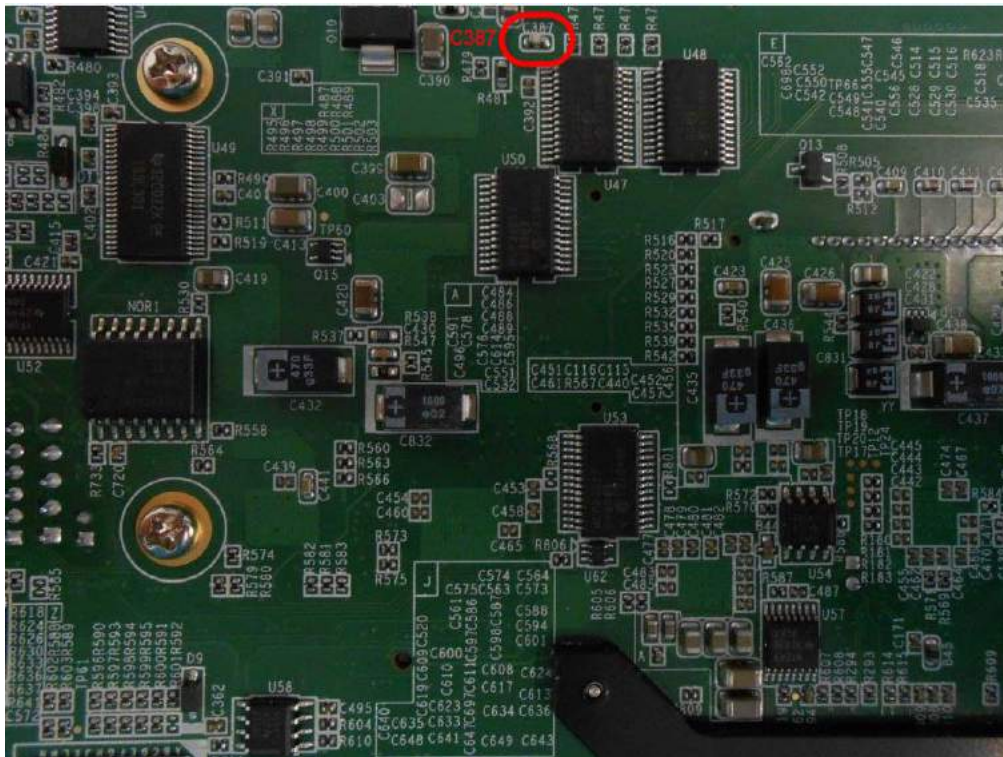
4.2 USB Device Not Work

- **Description:** USB 3.0 port could not work even Linux kernel loaded. The cause is 5V rail turned off due to overshoot/undershoot protection.
- **Workaround:** A couple different options are still under investigation for their effectiveness.
 1. Increase 5V overshoot/undershoot margin in with UCD9090 XML File (UCD9090_104_A04.XML) in TI Fusion Power Manager Tool so 5V rail would not be turned off.
 2. Remove C387 (56pf) extra capacitor on 5V rail to solve overshoot/undershoot symptom. (The solution will be applied from Rev 3.0 EVM and later revisions.)

- **Plans for a fix:** C387 will be removed from Rev 3.0 EVM. User who has Rev 2.0 EVM could choose to remove C387 or apply updated xml file to solve the symptom.

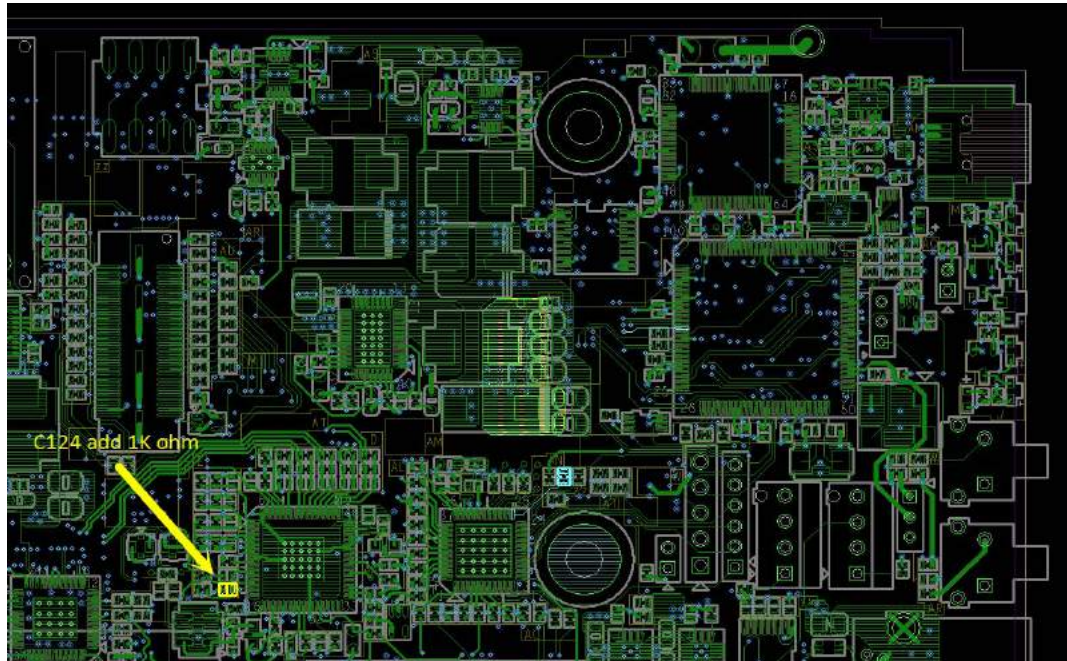
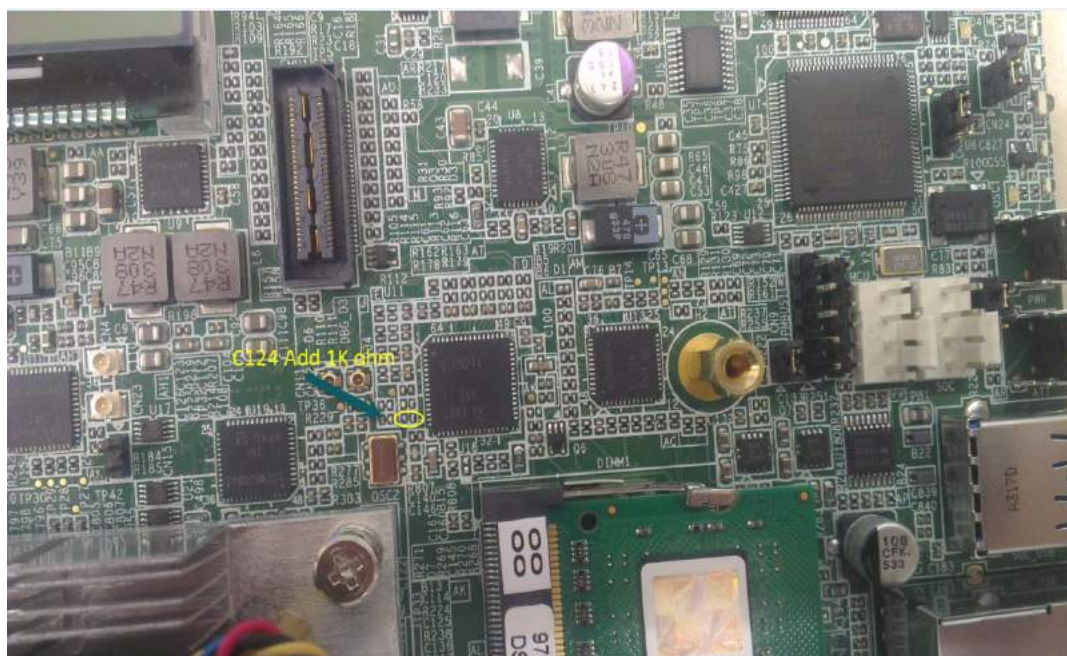
4.3 SoC PWR stop on Power-up

- Description: UCD controller detects a fault during power-on and aborts the power-on sequence.
- Workaround: The fault comes from un-used CVDDT rail and FLT pin is floating. Adding a 1K ohm resistor on location C124 will pull-down the un-used FLT pin and avoid false fault signal.

- Plans for a fix: The 1Kohm resistor is added before Rev 2.0 EVM shipping.

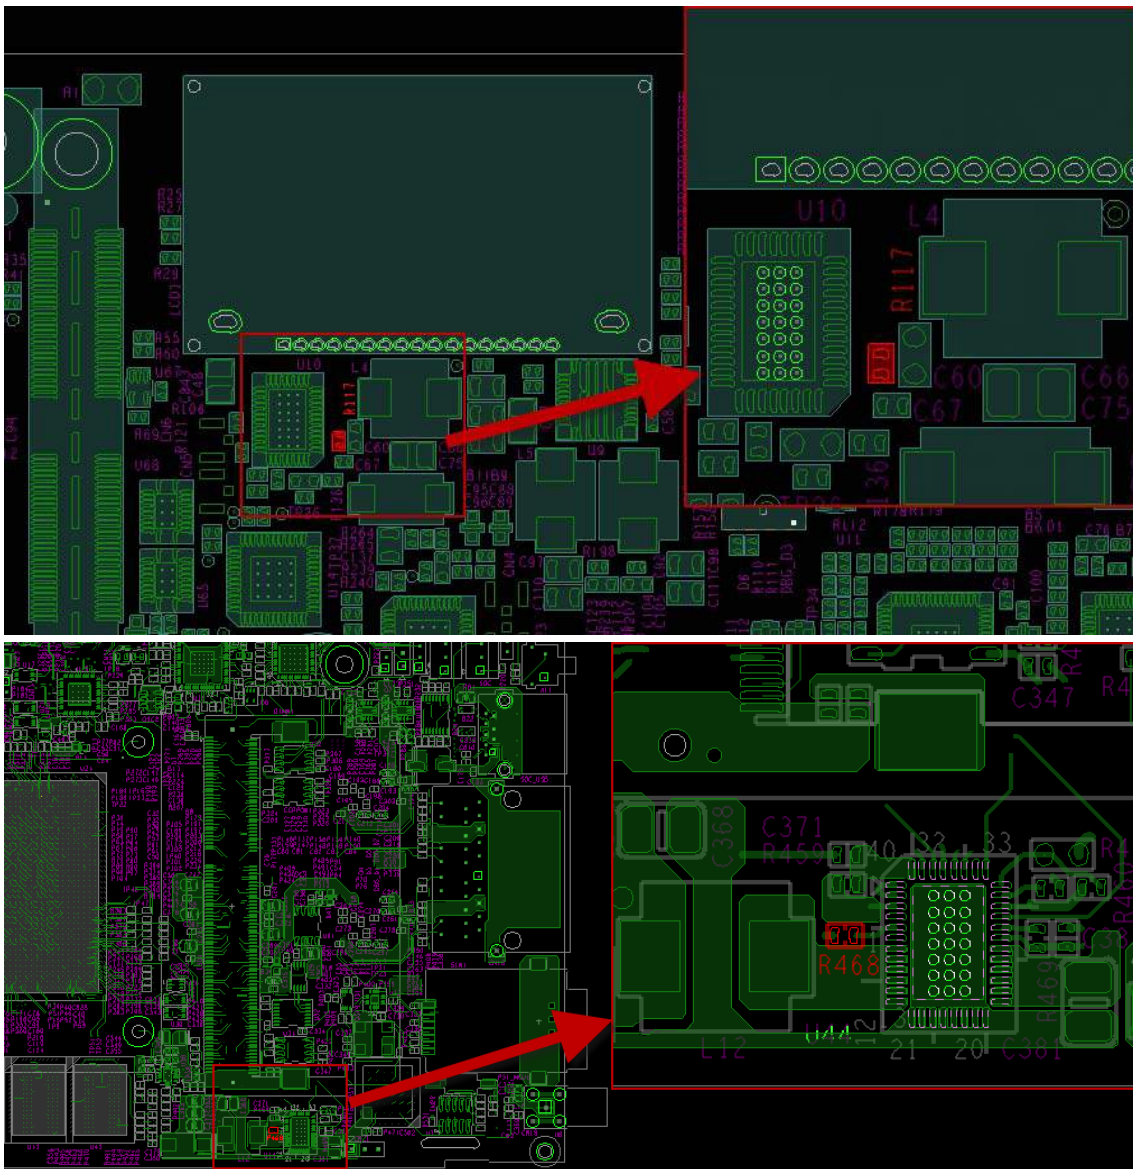
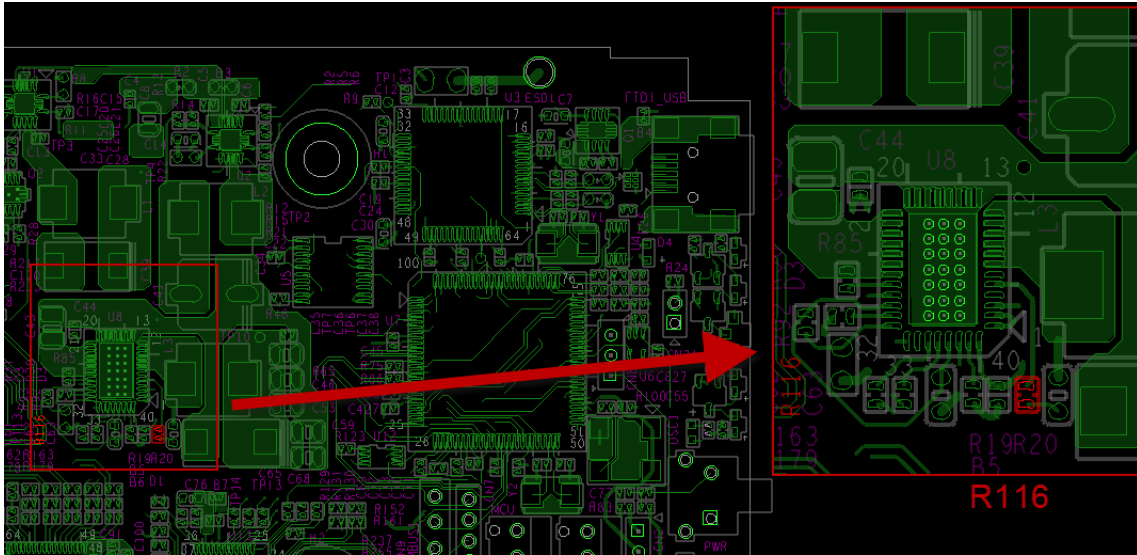
4.4 Warning Messages in TFTP test on NAND Flash

- **Description:** When performing TFTP test on NAND in Linux, there are warning messages frequently. The symptom is related to power phase noise coupling on EMIF signals. Increasing boot resistor value could mitigate the issue but won't solve the issue completely.
- **Workaround:**
 1. Change R117 from 0 ohm to 10 ohm (boot resistor for CVDD/U10/UCD74120)
 2. Change R468 from 0 ohm to 10 ohm (boot resistor for CVDD/U44/UCD74120)
 3. Change R116 from 0 ohm to 10 ohm (boot resistor for VCC1V5/U8/UCD74111)

- Plans for a fix: This issue is found in Rev 3.0 and it will also affect Rev 2.0 EVM. The resistor value change will be installed on all Rev 3.1 board before shipping. Root causes are still under investigation.

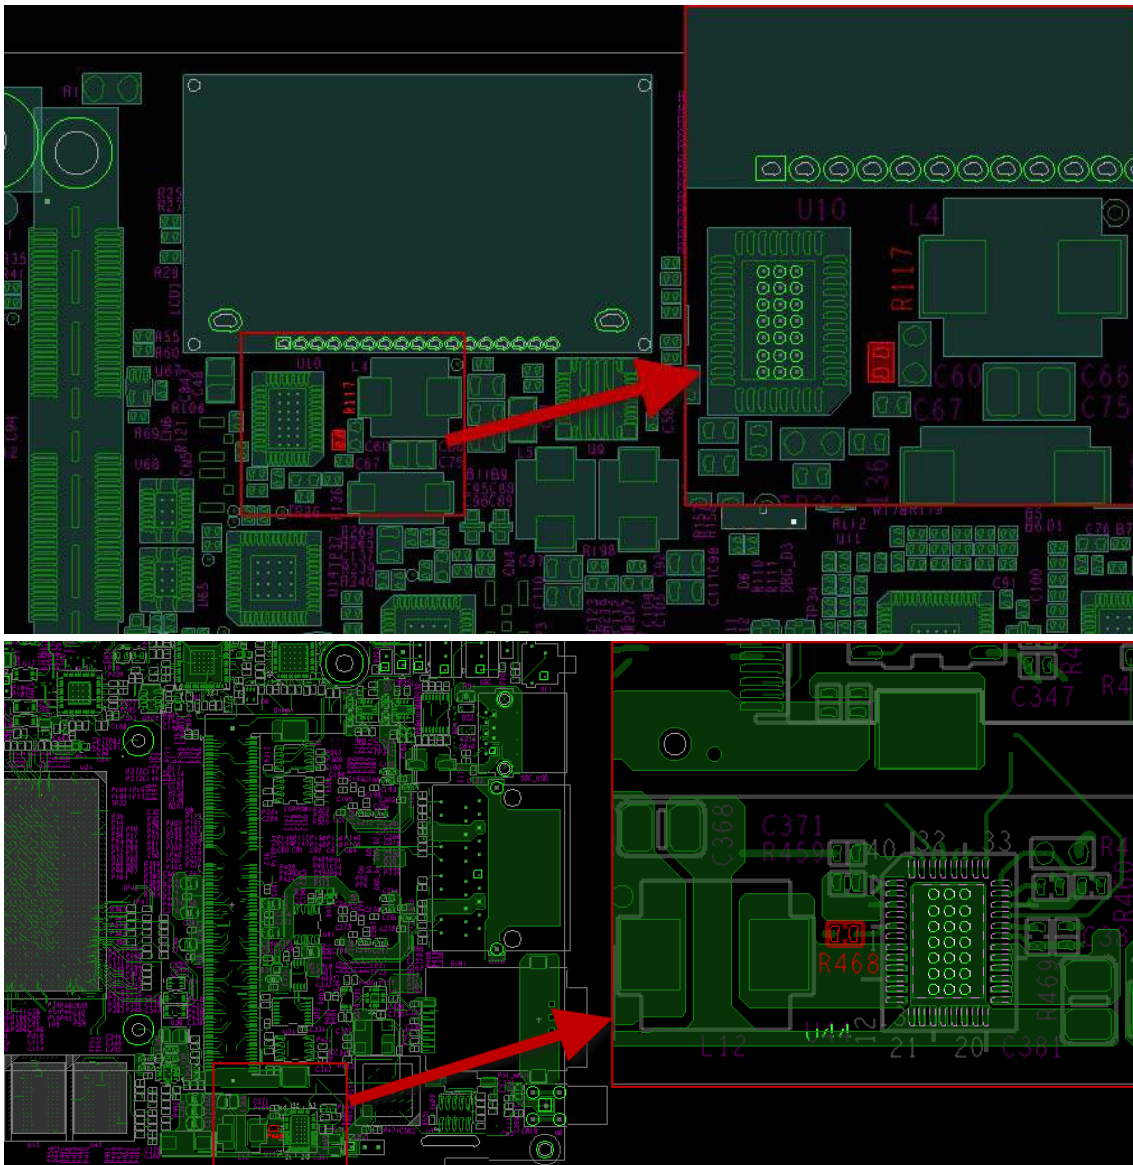
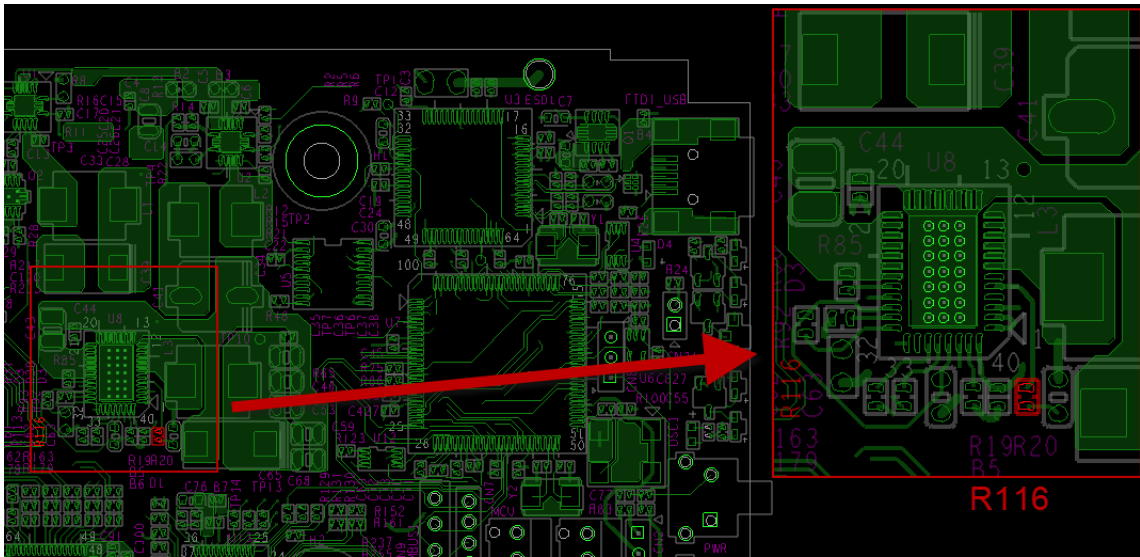
6.1 Warning Messages in TFTP test on NAND Flash

- Description: When performing TFTP test on NAND in Linux, there are warning messages frequently. The symptom is related to power phase noise coupling on EMIF signals. Increasing boot resistor value could mitigate the issue but won't solve the issue completely. (This is the same issue as 4.4.)
- Workaround:
 1. Change R117 from 0 ohm to 10 ohm (boot resistor for CVDD/U10/UCD74120)
 2. Change R468 from 0 ohm to 10 ohm (boot resistor for CVDD/U44/UCD74120)
 3. Change R116 from 0 ohm to 10 ohm (boot resistor for VCC1V5/U8/UCD74111)

Plans for a fix: The resistor value change will be installed on all Rev 3.1 board before shipping. If there are still NAND warning messages, please perform following rework: “add 100pF on R/B# of EMIF interface close to SoC (on the via of net “EMIFWAIT0”, green print on the via should be removed) and add GND connection to pin1 of C344”.

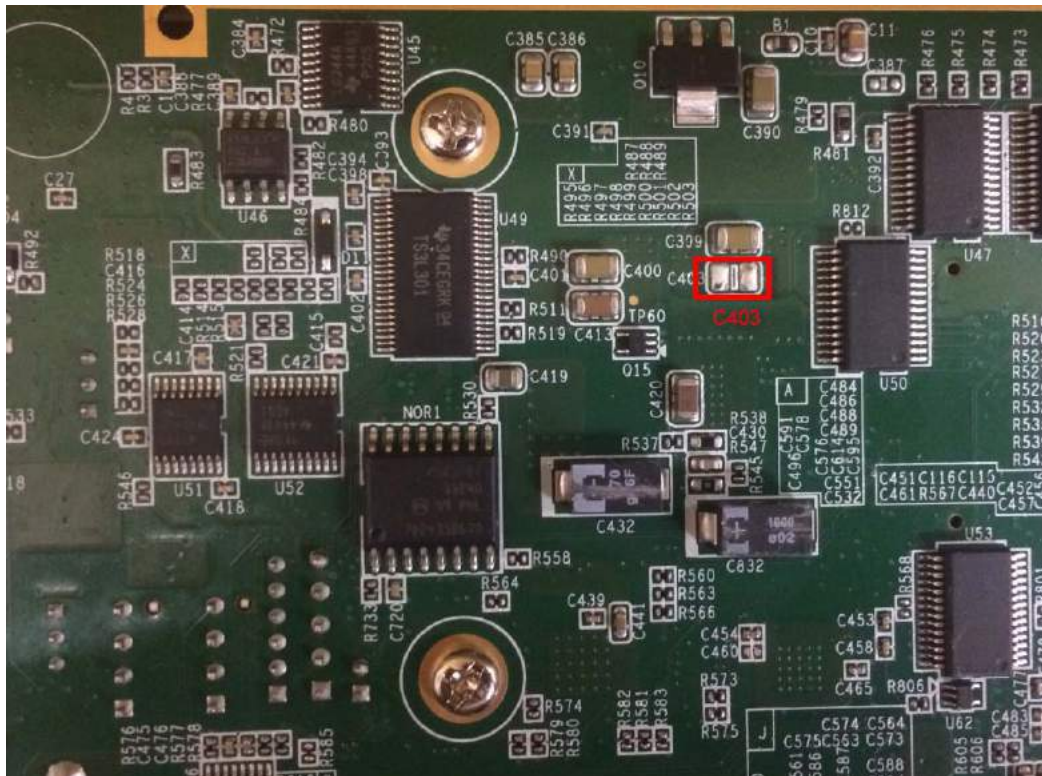
8.3 USB Device failures

- Description: USB not functional after power-up even after Linux kernel loaded. The cause is power supply instability of the VCC5 supply on some boards. This instability

occurs because the VCC5 supply has no load at startup until after the USB port is enabled in host mode. Once USB is enabled in host mode, the instability is eliminated.

2. The instability can be resolved by adding a small load to the VCC5 supply. You can install a 510 ohm resistor on the NL capacitor location C403. This location is shown in the picture below. Note: this is on the back-side of the board.

- Plans for a fix: C403 will be stuffed with a 510 ohm resistor on all new production units. The UCD9090 configuration loaded will contain the standard 15% limits for overshoot and undershoot.
