# EVMK2HX Known Issues

## 1. Software and Firmware Version List

EVM Revision 1.1 could be identified by sticker on RTM Connector, and the PCB Revision is A102-1 and is located on bottom of board near GPS Antenna Input

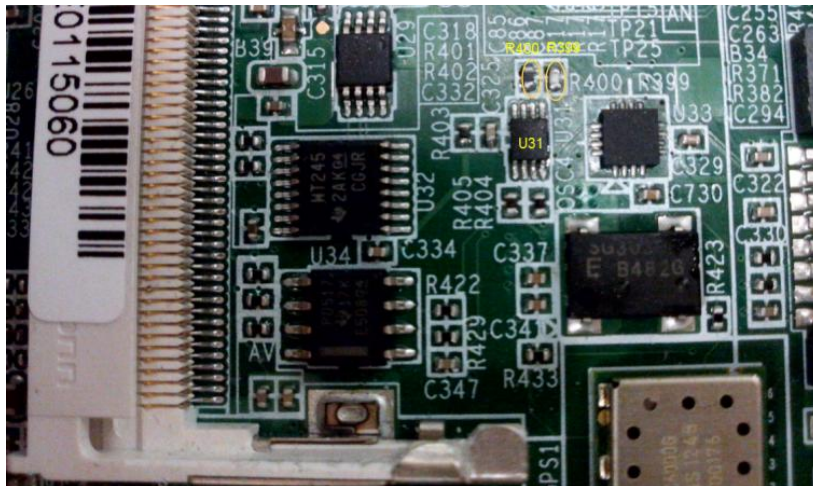
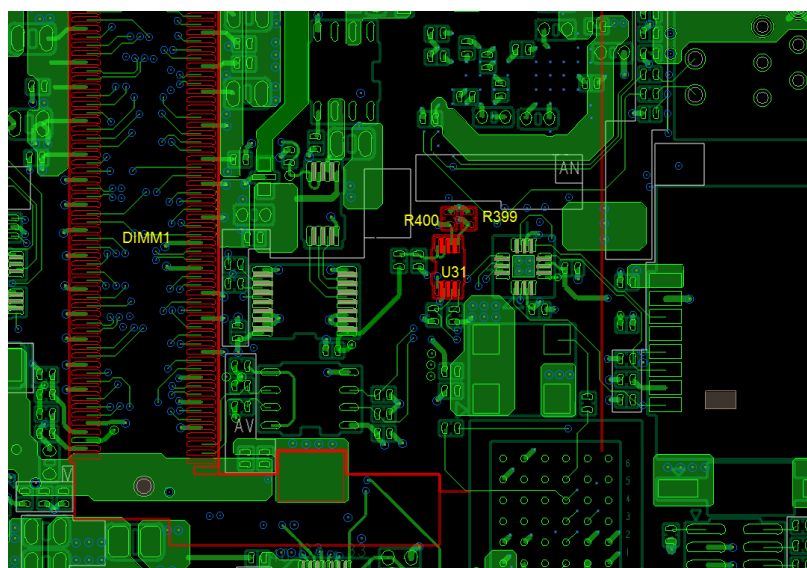
### 2.1 EMAC Link Down Issue

- Description: Noise on MDCLK signal impacts stability of the MDIO link. When Linux kernel sees MDIO link go down it tears down data link as well. Have not seen an issue with using MDIO link to configure external PHY.
- Workaround: Different options under investigation.
  1. Modify code not to depend upon MDIO link remaining active for EMAC communication
  2. Add stronger pull-up resistors on MDCLK and MDIO signal, by replacing R399/R400 from 4.7 kohm with 220 ohm resistors (0402 sized)

- Plans for a fix: Will clean up routing of MDCLK signal on Rev2.0. BOM will also be changed on future builds to incorporate 220ohm resistor pull-up changes.

- Workaround: R399 and R400 are changed from 4.7 kohm to 220 ohm resistors (0402 sized) in Rev 1.1 EVM.

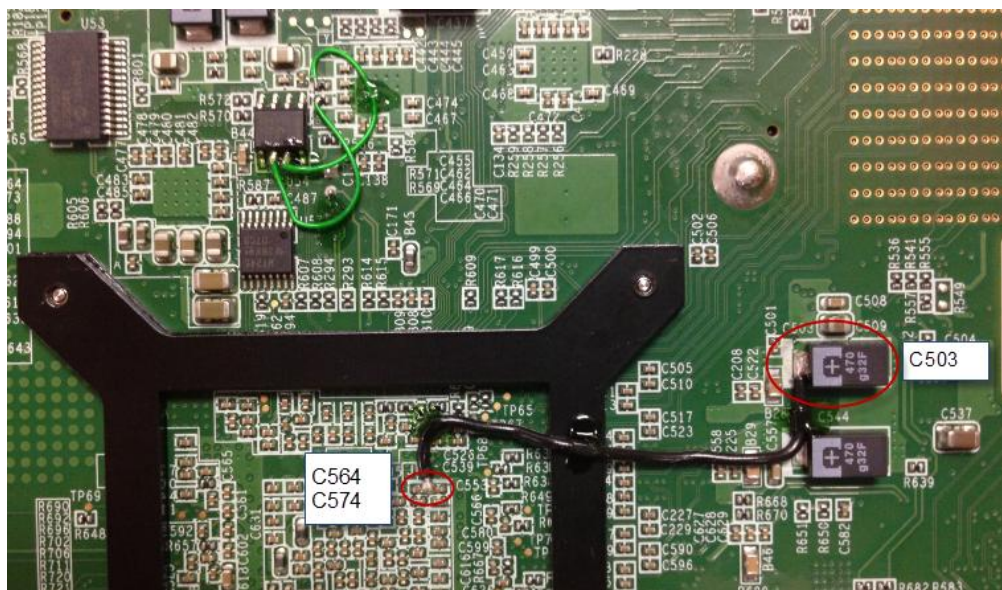
## 2.2 VCC0V85 Voltage Drop Issue

- Description: The trace width of the VCC085 signal is too narrow and causes a voltage drop at the pin of the SOC. Since this supply is used for SerDes interfaces it could cause SerDes interfaces to lose link. This issue has only been identified and observed on the SGMII.
- Workaround: A couple different options are still under investigation for their effectiveness.
  1. Add external wire to provided adequate patch for expected current from pin 1 of “C503” (net VCC0V85) to pin 1 of “C564, C574” (net VDD0V85). (Wire length = 5 cm)

Note: That the rework should not link to GND and cause short circuit.

- Plans for a fix: The trace width will be fixed on Rev2.0. The filter element on AVDDALV requires an increased current capacity (suggest up to 4A) to allow for margin on worse-case power as per latest Snowbush power estimates when all SERDES are active. Increase of current capacity on filtering elements for AVDDAHV also recommended (suggest up to 3A). Please see latest estimates below. CVDD power budgeted already on the DSP AVS supply. Both of these nets shall be implemented as copper pours up to the filters and as a plane afterwards to minimize resistance and inductance and maximize plane capacitance.

- Workaround: An external wire is added to provided adequate patch for expected current from pin 1 of “C503” (net VCC0V85) to pin 1 “C564, C574” (net VDD0V85). (Wire length = 5 cm). Also, the wire is glued on heat sink back plate for stability.

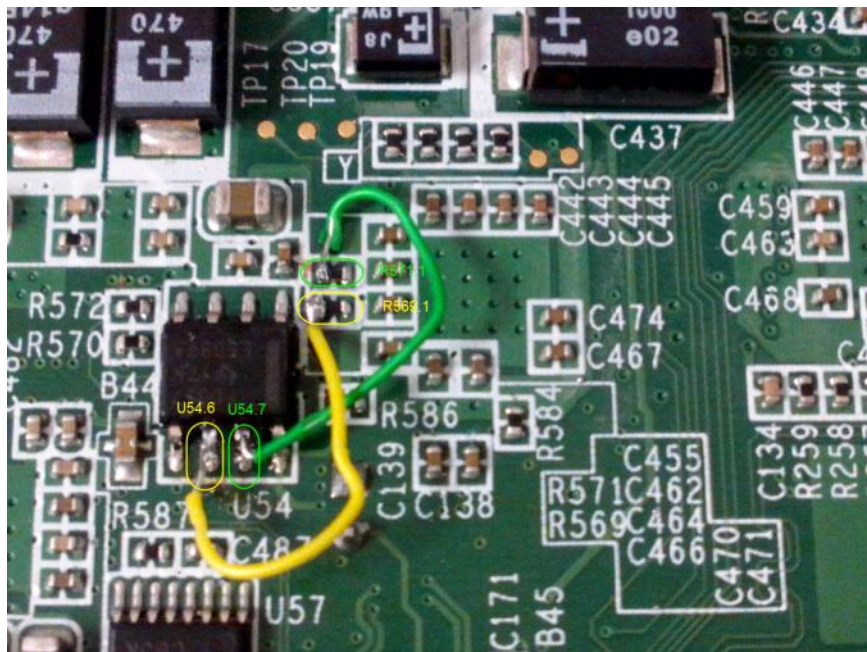
## 2.3 I2C SDA/SCL Reserve Issue

- Description: SCL and SDA are swapped on U54 bus repeater. Impacts I2C going to 120p Expansion Connector and Zone 3 RTM connector.
- Workaround: Cut the jumper wire (30AWG) to swapped signal of EXP\_SDA2\_3V3 and EXP\_SCL2\_3V3. Two wire each to similar yellow and green to link from U54.6 to R569.1 and U54.7 to R571.1 .

- Plans for a fix: This will be corrected on Rev2.0.

- Workaround: External rework wires (30AWG) are added to swapped signal of EXP\_SDA2\_3V3 and EXP\_SCL2\_3V3.
