# EVMK2HX Known Issues

## 2. EVMK2HX Rev 1.1 Known Issues

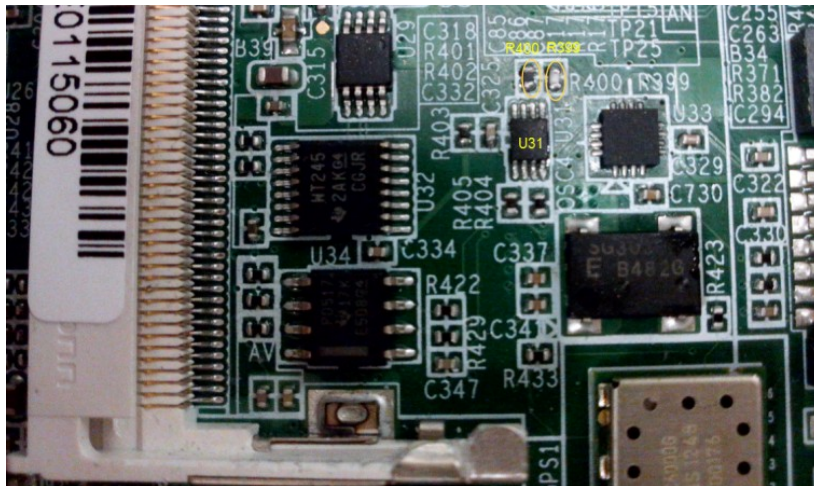
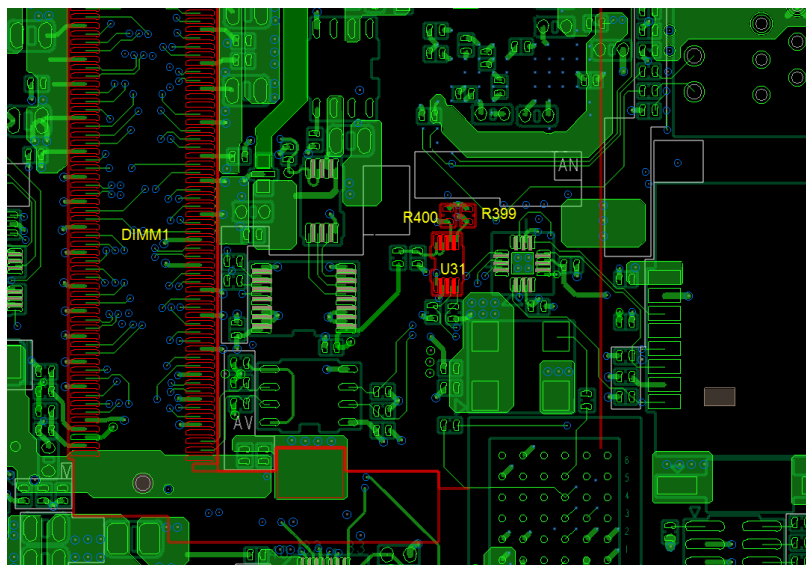
### 2.1 EMAC Link Down Issue

- Description: Noise on MDCLK signal impacts stability of the MDIO link. When Linux kernel sees MDIO link go down it tears down data link as well. Have not seen an issue with using MDIO link to configure external PHY.
- Workaround: Different options under investigation.
  1. Modify code not to depend upon MDIO link remaining active for EMAC communication
  2. Add stronger pull-up resistors on MDCLK and MDIO signal, by replacing R399/R400 from 4.7 kohm with 220 ohm resistors (0402 sized)

- Plans for a fix: Will clean up routing of MDCLK signal on Rev2.0. BOM will also be changed on future builds to incorporate 220ohm resistor pull-up changes.

- Workaround: R399 and R400 are changed from 4.7 kohm to 220 ohm resistors (0402 sized) in Rev 1.1 EVM.

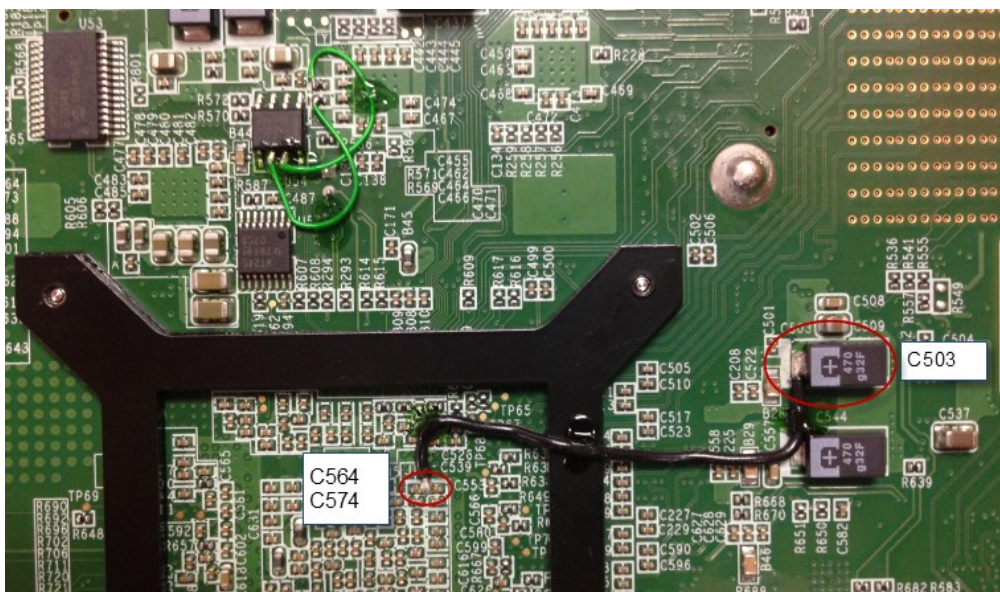
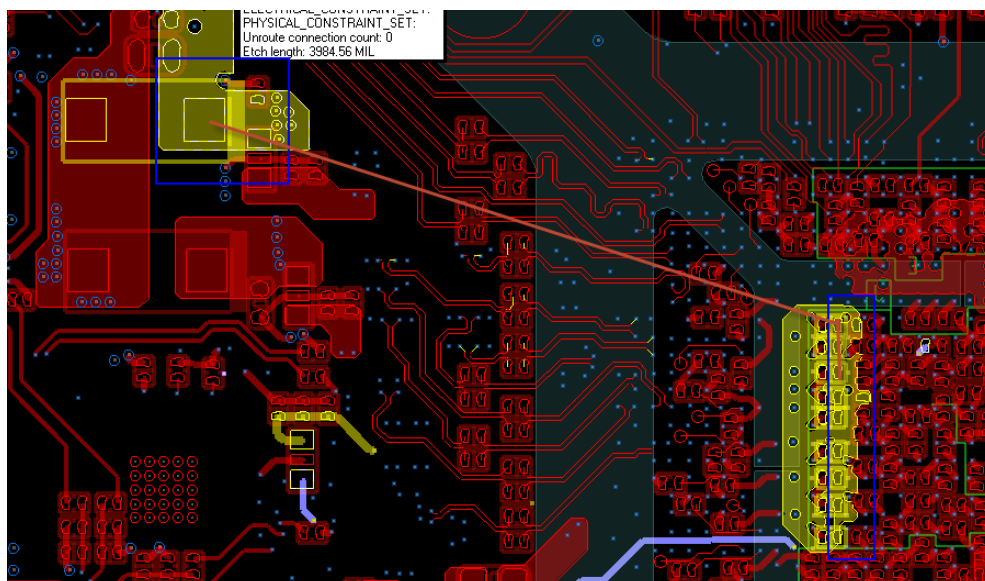
## 2.2 VCC0V85 Voltage Drop Issue

- **Description:** The trace width of the VCC085 signal is too narrow and causes a voltage drop at the pin of the SOC. Since this supply is used for SerDes interfaces it could cause SerDes interfaces to lose link. This issue has only been identified and observed on the SGMII.
- **Workaround:** A couple different options are still under investigation for their effectiveness.
  1. Add external wire to provided adequate patch for expected current from pin 1 of "C503" (net VCC0V85) to pin 1 of "C564, C574" (net VDD0V85). (Wire length = 5 cm)

Note: That the rework should not link to GND and cause short circuit.

- Plans for a fix: The trace width will be fixed on Rev2.0. The filter element on AVDDALV requires an increased current capacity (suggest up to 4A) to allow for margin on worse-case power as per latest Snowbush power estimates when all SERDES are active. Increase of current capacity on filtering elements for AVDDAHV also recommended (suggest up to 3A). Please see latest estimates below. CVDD power budgeted already on the DSP AVS supply. Both of these nets shall be implemented as copper pours up to the filters and as a plane afterwards to minimize resistance and inductance and maximize plane capacitance.

- Workaround: An external wire is added to provided adequate patch for expected current from pin 1 of "C503" (net VCC0V85) to pin 1 "C564, C574" (net VDD0V85). (Wire length = 5 cm). Also, the wire is glued on heat sink back plate for stability.

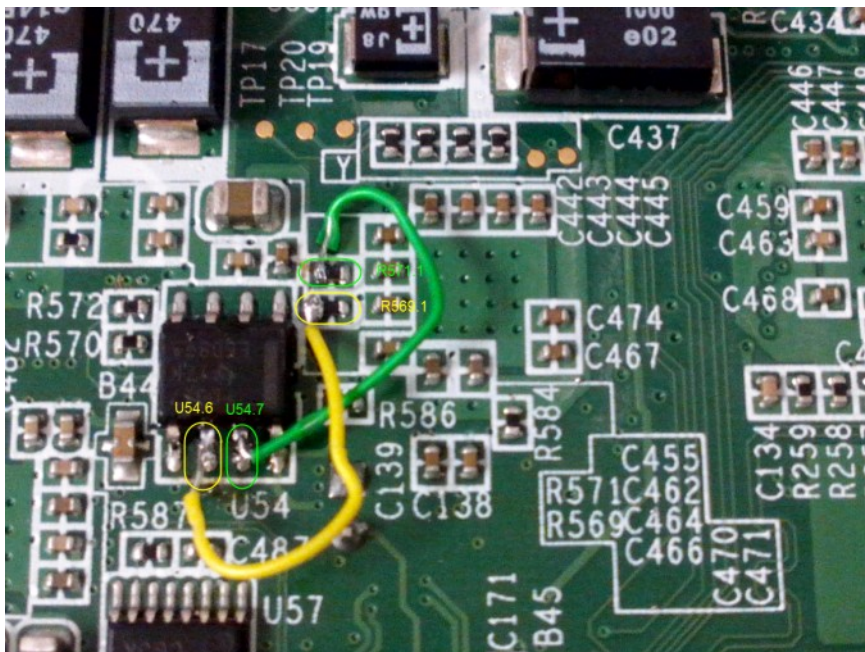
### 2.3 I2C SDA/SCL Reserve Issue

- Description: SCL and SDA are swapped on U54 bus repeater. Impacts I2C going to 120p Expansion Connector and Zone 3 RTM connector.
- Workaround: Cut the jumper wire (30AWG) to swapped signal of EXP\_SDA2\_3V3 and EXP\_SCL2\_3V3. Two wire each to similar yellow and green to link from U54.6 to R569.1 and U54.7 to R571.1 .

- Plans for a fix: This will be corrected on Rev2.0.

- Workaround: External rework wires (30AWG) are added to swapped signal of EXP\_SDA2\_3V3 and EXP\_SCL2\_3V3.

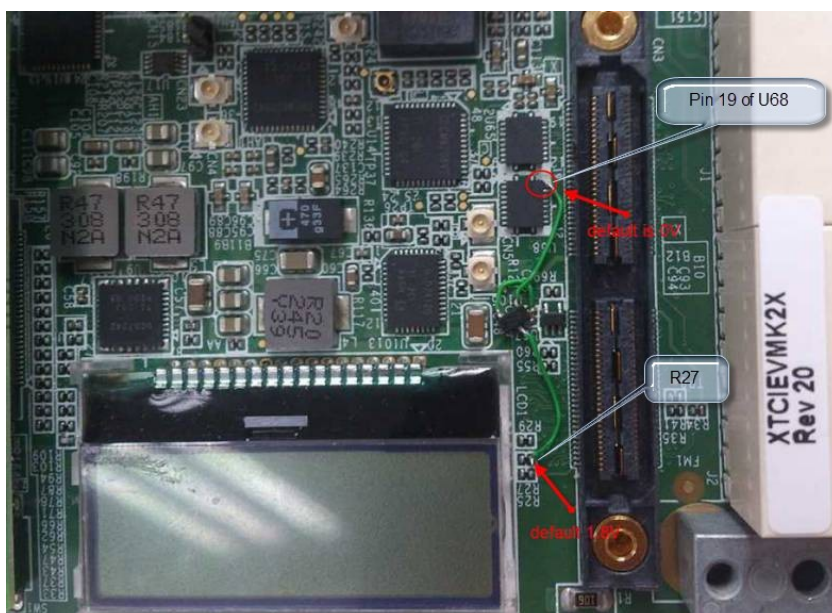
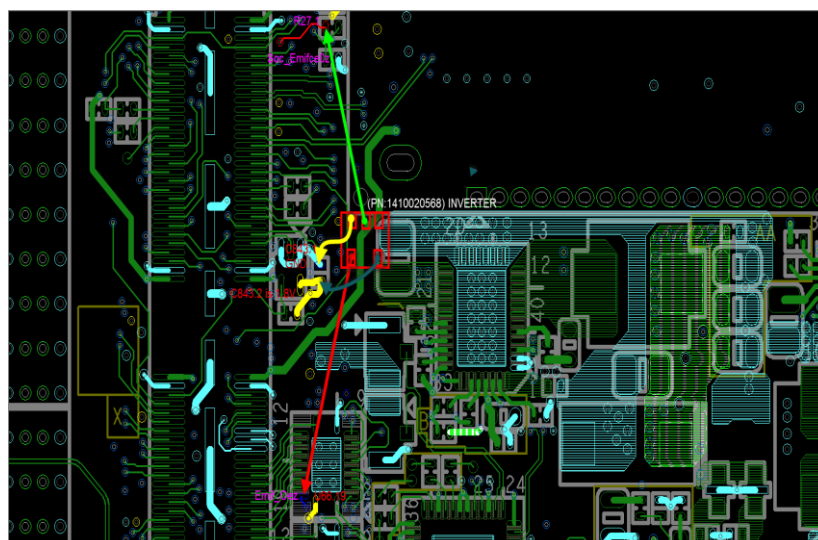
### 4.1 EMIF and NAND Test cannot be synchronized

- Description: SoC could not access NAND flash through EMIF interface, and there will be one cause data transmission errors.
- Workaround:
  1. Add inverter (SN74LVC1G04DVR).
  2. Add wire (30AWG) from inverter PIN 3 to C843.1 (GND),
  3. Add wire (30AWG) from inverter PIN 5 to C843.2 (VCC1V8)
  4. Add wire (30AWG) from inverter PIN 2 to R27.1 (SOC\_EMIFCE0Z)
  5. Add wire (30AWG) from inverter PIN 4 to U66.19 (EMIF\_OEz).

- Plans for a fix: The rework is installed on all Rev 2.0 board before shipping.

1. Add inverter (SN74LVC1G04DVR).
2. Add wire (30AWG) from inverter PIN 3 to C843.1 (GND),
3. Add wire (30AWG) from inverter PIN 5 to C843.2 (VCC1V8)
4. Add wire (30AWG) from inverter PIN 2 to R27.1 (SOC\_EMIFCE0Z)
5. Add wire (30AWG) from inverter PIN 4 to U66.19 (EMIF\_OEz).

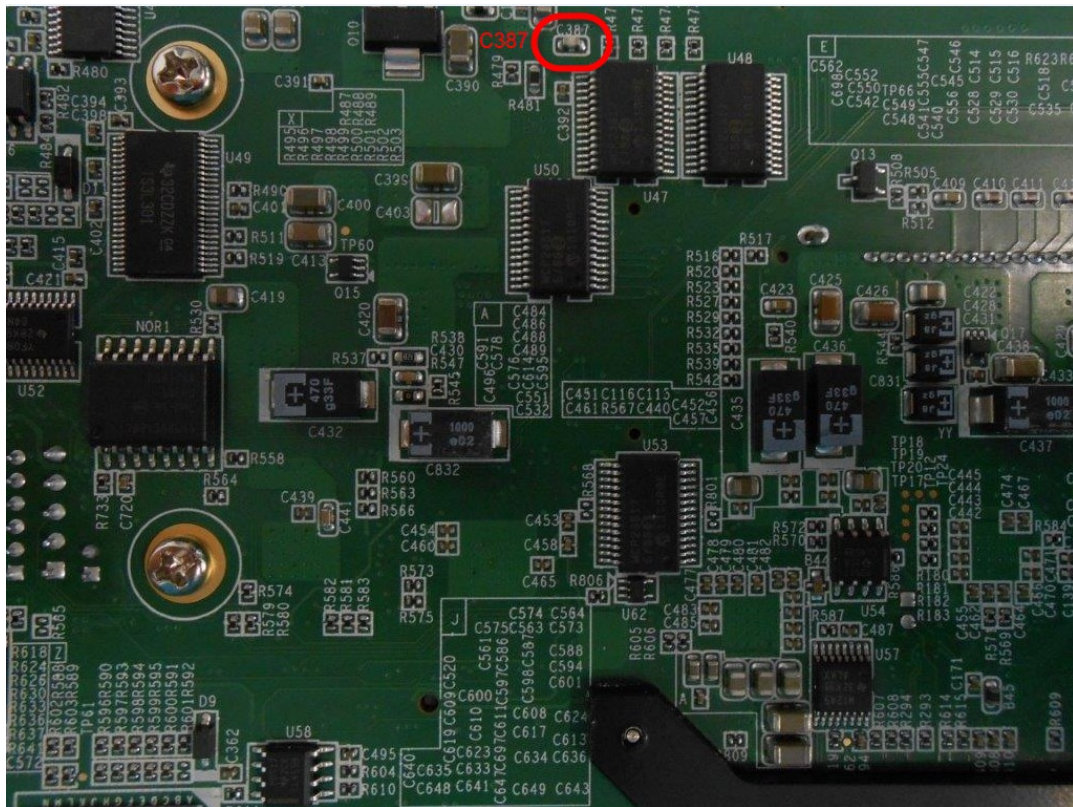
## 4.2 USB Device not work

- Description: USB 3.0 port could not work even Linux kernel loaded. The cause is 5V rail turned off due to overshoot/undershoot protection.
- Workaround: A couple different options are still under investigation for their effectiveness.
  1. Increase 5V overshoot/undershoot margin in with UCD9090 XML File (UCD9090\_104\_A04.XML) in TI Fusion Power Manager Tool so 5V rail would not be turned off.
  2. Remove C387 (56pf) extra capacitor on 5V rail to solve overshoot/undershoot symptom.

- Plans for a fix: C387 will be removed in next revision EVM. User could remove C387 or apply updated xml file to solve the symptom.

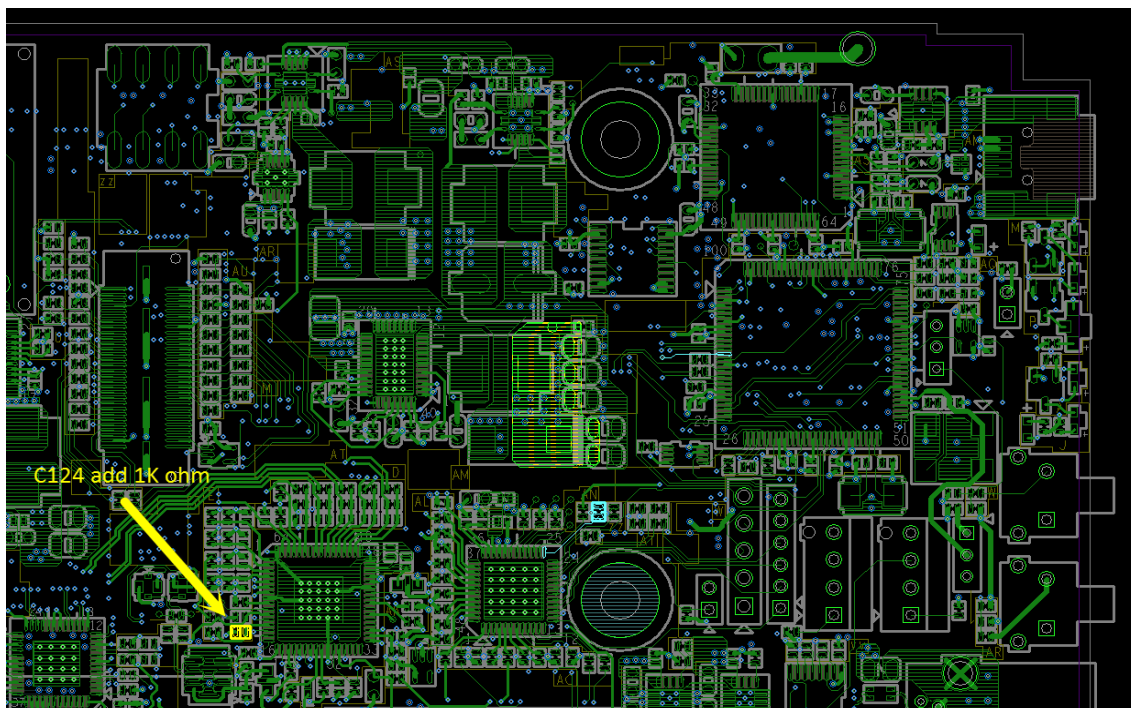
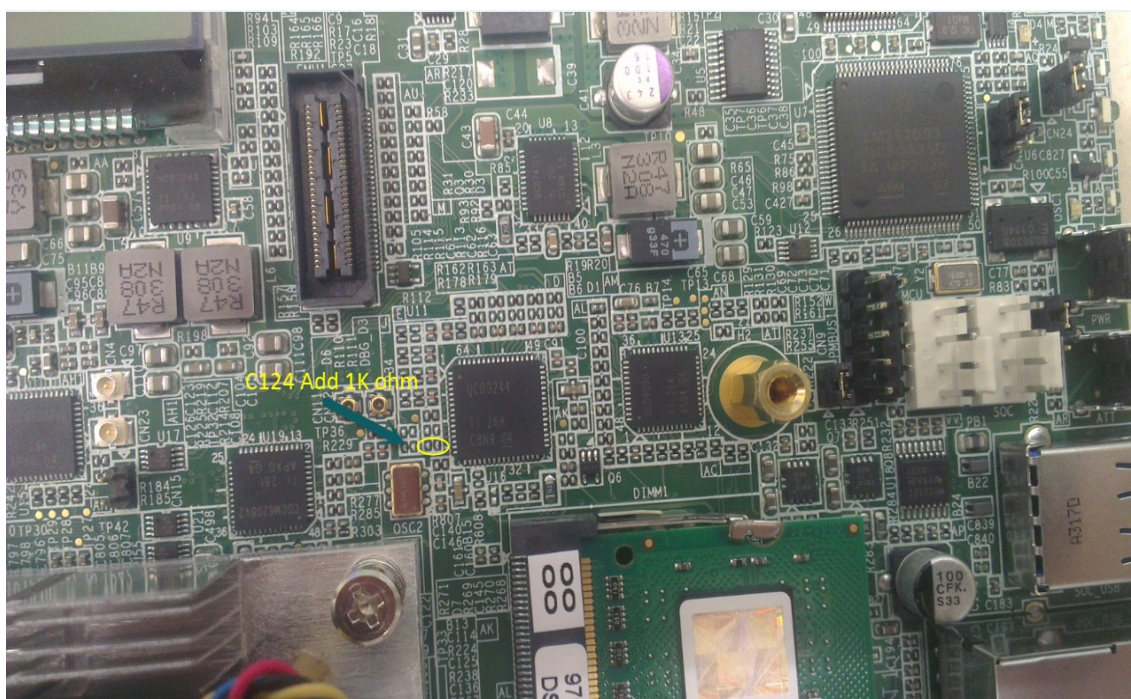
### 4.3 Power up will happen SoC PWR stop

- Description: UCD controller detects a fault during power-on and aborts the power-on sequence.
- Workaround: The fault comes from un-used CVDDT rail and FLT pin is floating. Adding a 1K ohm resistor on location C124 will pull-down the un-used FLT pin and avoid false fault signal.

- Plans for a fix: The 1Kohm resistor is added before Rev 2.0 EVM shipping.

- #### ▪ Workaround: Add a 1K ohm resistor on to GND.
