TMDXEVM6670L EVM A102-1 Workaround List at page.21 of the schematics:

TMDXEVM6670L EVM A102-1 Workaround List at page.33 of the schematics:

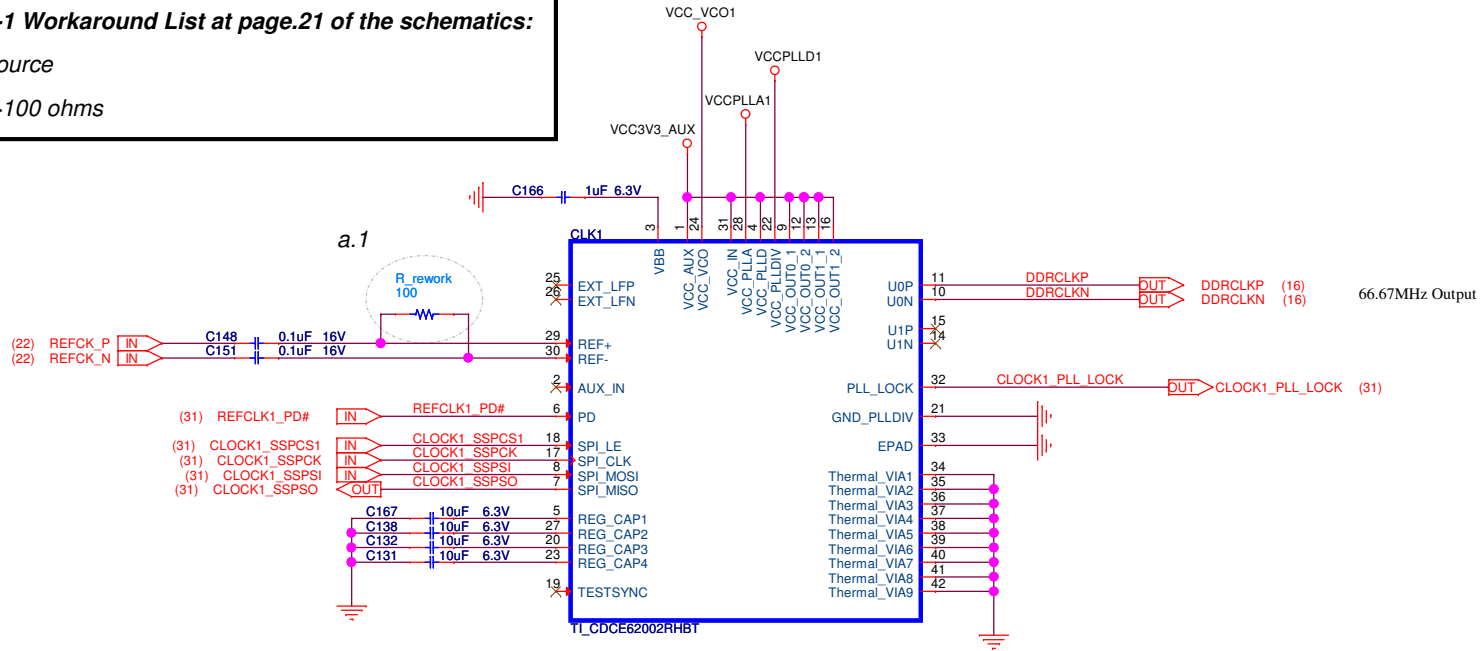
CLOCK GEN1 (DDR3)

a. Improving the clock source

a.1 Additional R ->100 ohms

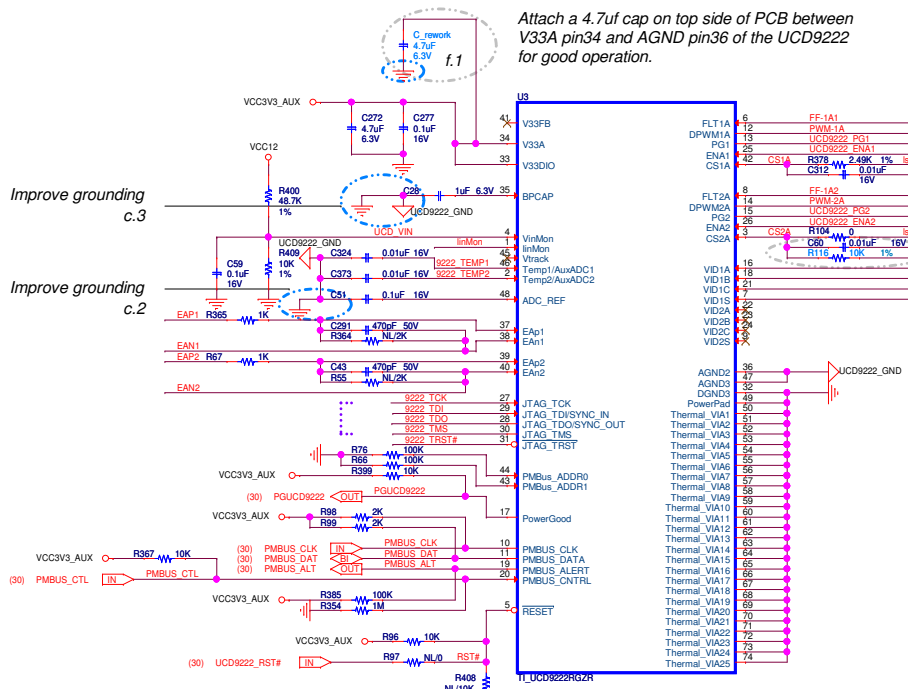
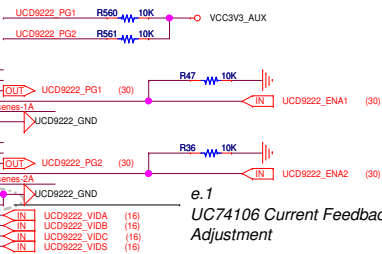
Improve UCD9244 analog power

Attach a 4.7uf cap on top side of PCB between V33A pin34 and AGND pin36 of the UCD9222 for good operation.

Improve grounding
c.3

Improve grounding
c.2

Improve grounding
c.1

The UCD9222 was halt in POR state, this was caused by the incorrect connection of the 74110 power pad to analog ground.

The changes at the BPCAP pin would not have been needed if the attached capacitor was on the same side and located close to the pin.

The additional capacitor on the V33A/V33D pin is needed to improve decoupling of this sensitive circuitry.

Note that this would not have been necessary had the available decoupling been implemented adjacent to the UCD9222 on the same side so that vias were not needed.

- a. Modify the DCR sensing circuitry of the L2 inductor
 - a.1 R456 -> 1.3k ohms
 - a.2 C365 -> 0.1uf cap
 - a.3 R121 -> 0 ohm
 - a.4 Additional R -> 931 ohms (across the ends of R123 and R124).
- b. Remove the snubber components.
 - b.1 Remove R462, C465.
- c. Improve the grounding on UCD9222_GND plan.

- c.1 C387 (BP3, the end of UCD9222_GND) -> GND
- c.2 C54 (ADC_REF, the end of UCD9222_GND)-> GND
- c.3 C28 (BPCAP, the end of UCD9222_GND) -> GND

f.1 Additional C -> 4.7uf between the pins of V33A and AGND on the UCD9222.

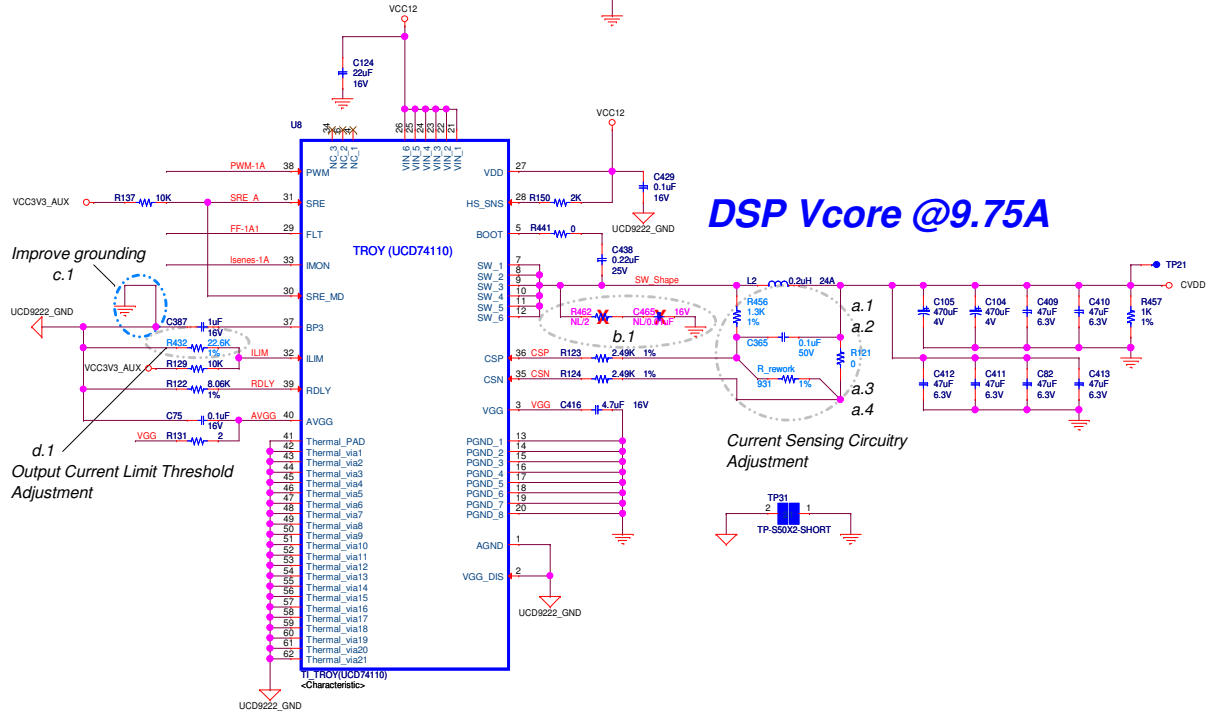
Current Sensing Circuitry Adjustment

e.1
UC74106 Current Feedback Adjustment

DSP Vcore @9.75A

d.1
Output Current Limit Threshold Adjustment

- d. Output Current Limit Setting Adjustment on UCD74110.
 - d.1 R432 -> 22.6k ohms
- e. Current feedback setting Adjustment on UCD74106.
 - e.1 R116 -> 10k ohms
- f. Improving UCD9222 V33A power supply.
