# **EVMK2HX Known Issues**

# 1. Software and Firmware Version List

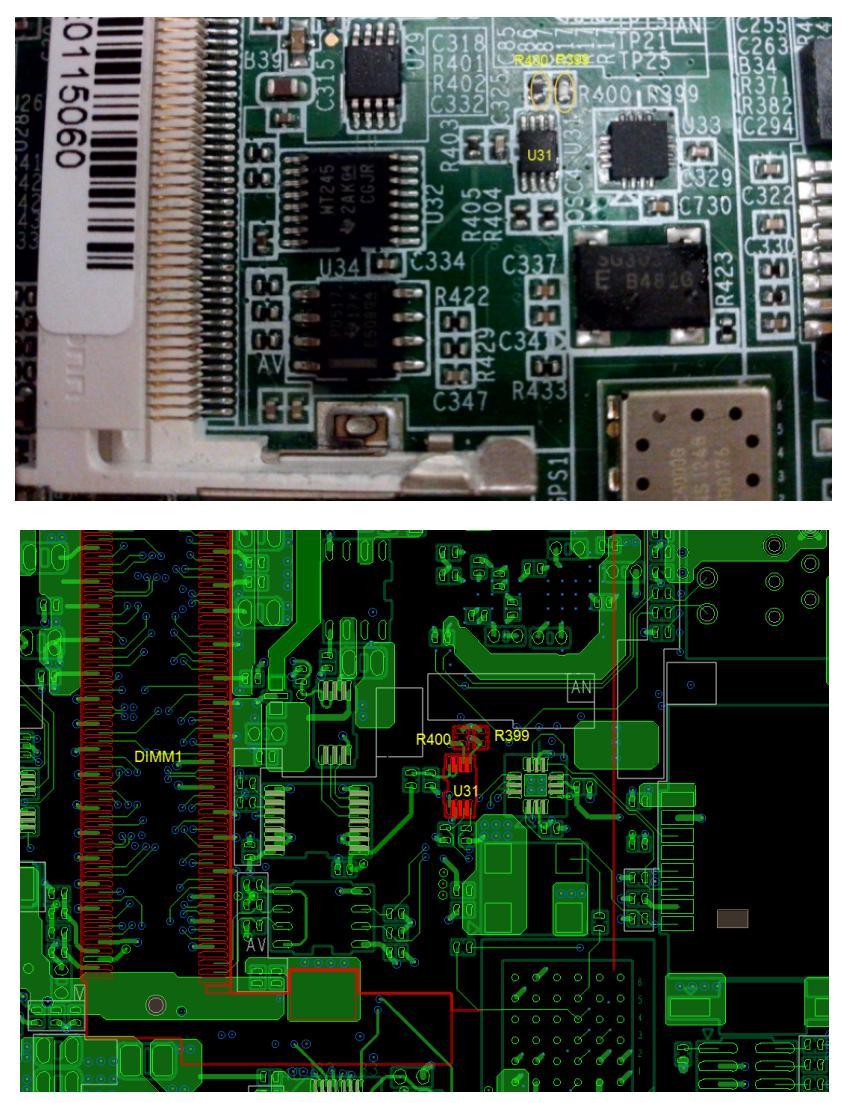
### 2.1 EMAC Link Down Issue

- <u>Description</u>: Noise on MDCLK signal impacts stability of the MDIO link. When Linux kernel sees MDIO link go down it tears down data link as well. Have not seen an issue with using MDIO link to configure external PHY.
- <u>Workaround</u>: Different options under investigation.
  - 1. Modify code not to depend upon MDIO link remaining active for EMAC communication
  - 2. Add stronger pull-up resistors on MDCLK and MDIO signal, by replacing R399/R400 from 4.7 kohm with 220 ohm resistors (0402 sized)

<u>Plans for a fix:</u> Will clean up routing of MDCLK signal on Rev2.0. BOM will also be changed on future builds to incorporate 220ohm resistor pull-up changes.

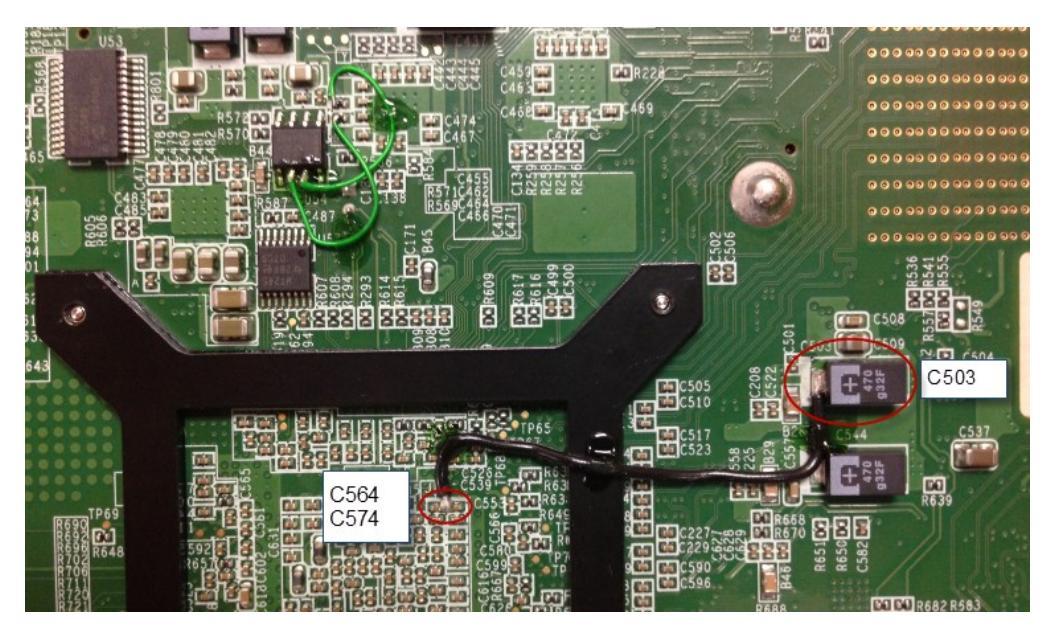
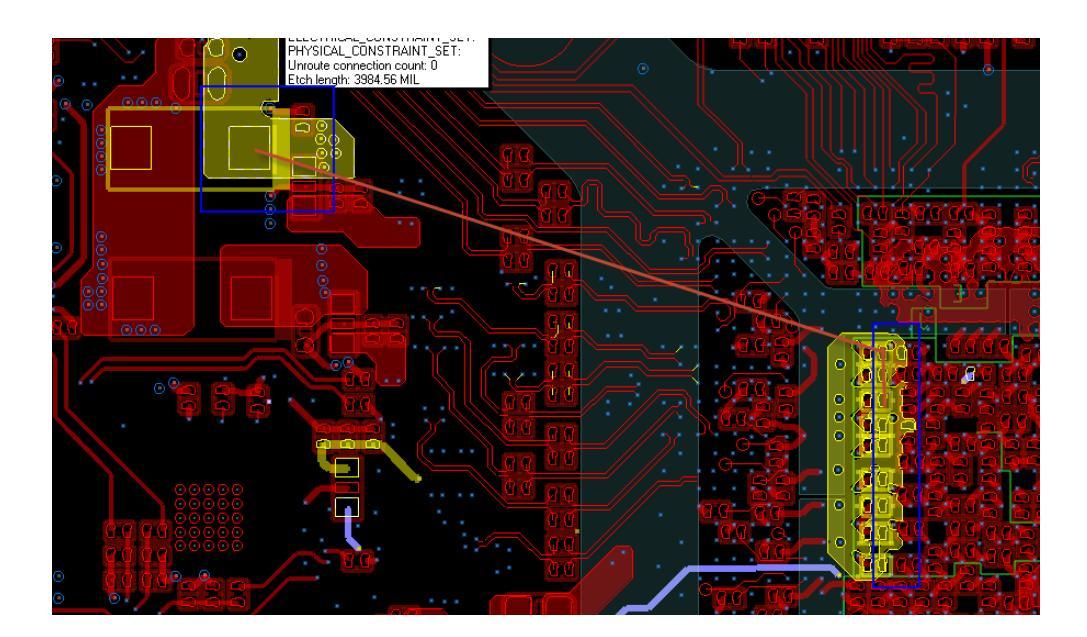
#### 2.2 VCC0V85 Voltage Drop Issue

- <u>Description</u>: The trace width of the VCC085 signal is too narrow and causes a voltage drop at the pin of the SOC. Since this supply is used for SerDes interfaces it could cause SerDes interfaces to lose link. This issue has only been identified and observed on the SGMII.
- <u>Workaround</u>: A couple different options are still under investigation for their effectiveness.
  - 1. Add external wire to provided adequate patch for expected current from pin 1 of "C503" (net VCC0V85) to pin 1 of "C564, C574" (net VDD0V85). (Wire length = 5 cm)

Note: That the rework should not link to GND and cause short circuit.

Plans for a fix: The trace width will be fixed on Rev2.0. The filter element on AVDDALV requires an increased current capacity (suggest up to 4A) to allow for margin on worse-case power as per latest Snowbush power estimates when all SERDES are active. Increase of current capacity on filtering elements for AVDDAHV also recommended (suggest up to 3A). Please see latest estimates below. CVDD power budgeted already on the DSP AVS supply. Both of these nets shall be implemented as copper pours up to the filters and as a plane afterwards to minimize resistance and inductance and maximize plane capacitance.

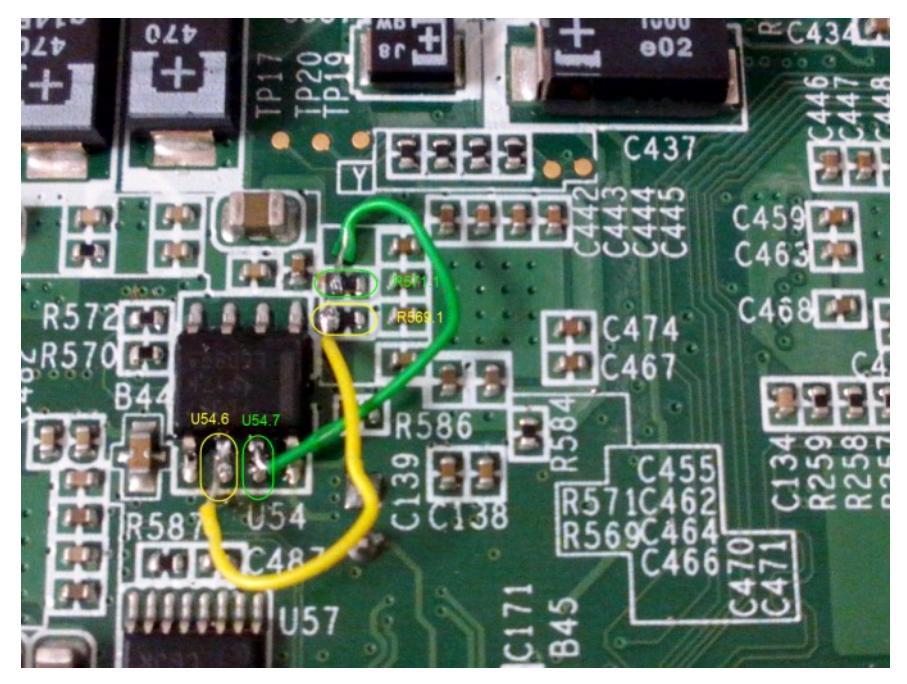
#### 2.3 I2C SDA/SCL Reserve Issue

- <u>Description</u>: SCL and SDA are swapped on U54 bus repeater. Impacts I2C going to 120p Expansion Connector and Zone 3 RTM connector.
- <u>Workaround</u>: Cut the jumper wire (30AWG) to swapped signal of EXP\_SDA2\_3V3 and EXP\_SCL2\_3V3. Two wire each to similar yellow and green to link from U54.6 to R569.1 and U54.7 to R571.1.

<u>Plans for a fix</u>: This will be corrected on Rev2.0.

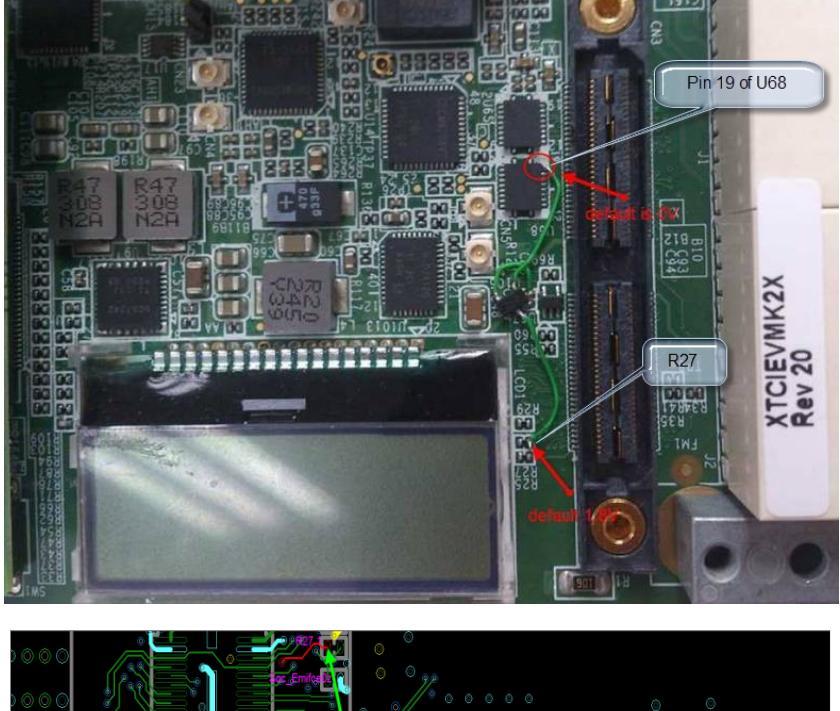
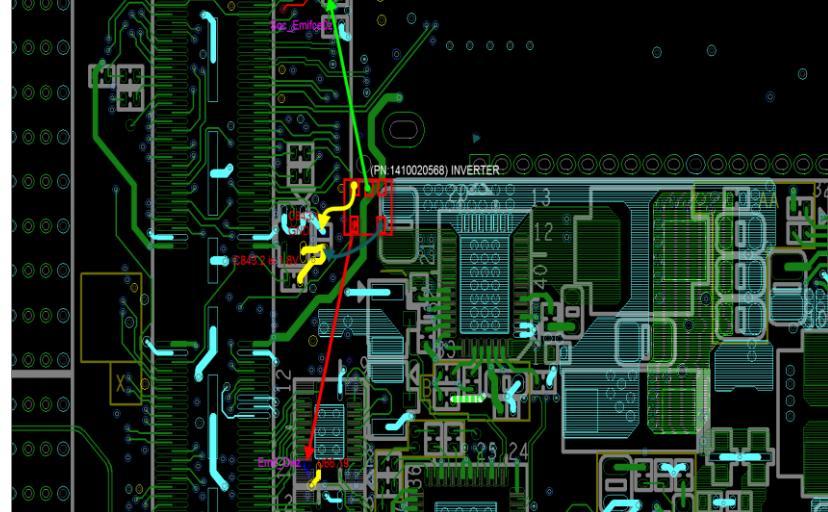
#### 4.1 EMIF and NAND Test cannot be Synchronized

<u>Description</u>: SoC could not access NAND flash through EMIF interface, and there will be one cause data transmission errors.

- 1. Add inverter (SN74LVC1G04DVR).
- 2. Add wire (30AWG) from inverter PIN 3 to C843.1 (GND),
- 3. Add wire (30AWG) from inverter PIN 5 to C843.2 (VCC1V8)
- 4. Add wire (30AWG) from inverter PIN 2 to R27.1 (SOC\_EMIFCE0Z)
- 5. Add wire (30AWG) from inverter PIN 4 to U66.19 (EMIF\_OEz).

Plans for a fix: The rework is installed on all Rev 2.0 board before shipping.

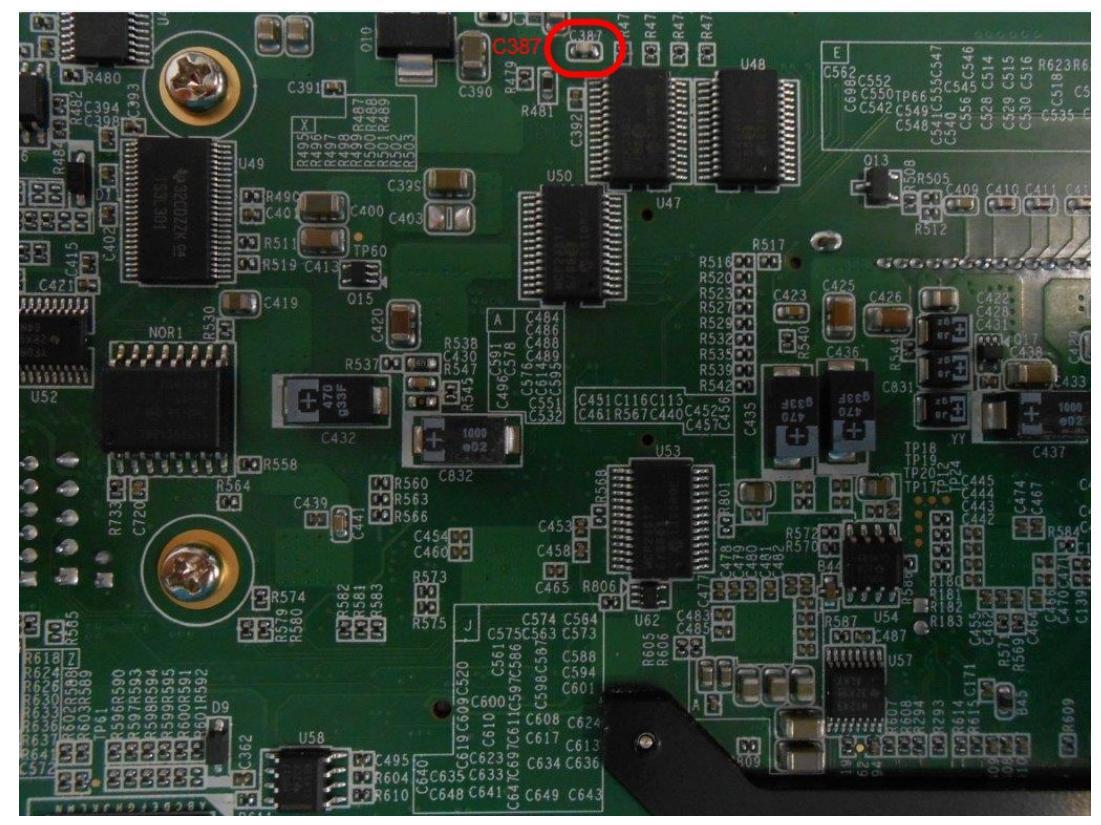
#### 4.2 USB Device Not Work

- <u>Description</u>: USB 3.0 port could not work even Linux kernel loaded. The cause is 5V rail turned off due to overshoot/undershoot protection.
- <u>Workaround</u>: A couple different options are still under investigation for their effectiveness.
  - Increase 5V overshoot/undershoot margin in with UCD9090 XML File (UCD9090\_104\_A04.XML) in TI Fusion Power Manager Tool so 5V rail would not be turned off.
  - 2. Remove C387 (56pf) extra capacitor on 5V rail to solve overshoot/undershoot symptom. (The solution will be applied from Rev 3.0 EVM and later revisions.)

<u>Plans for a fix:</u> C387 will be removed from Rev 3.0 EVM. User who has Rev 2.0 EVM could choose to remove C387 or apply updated xml file to solve the symptom.

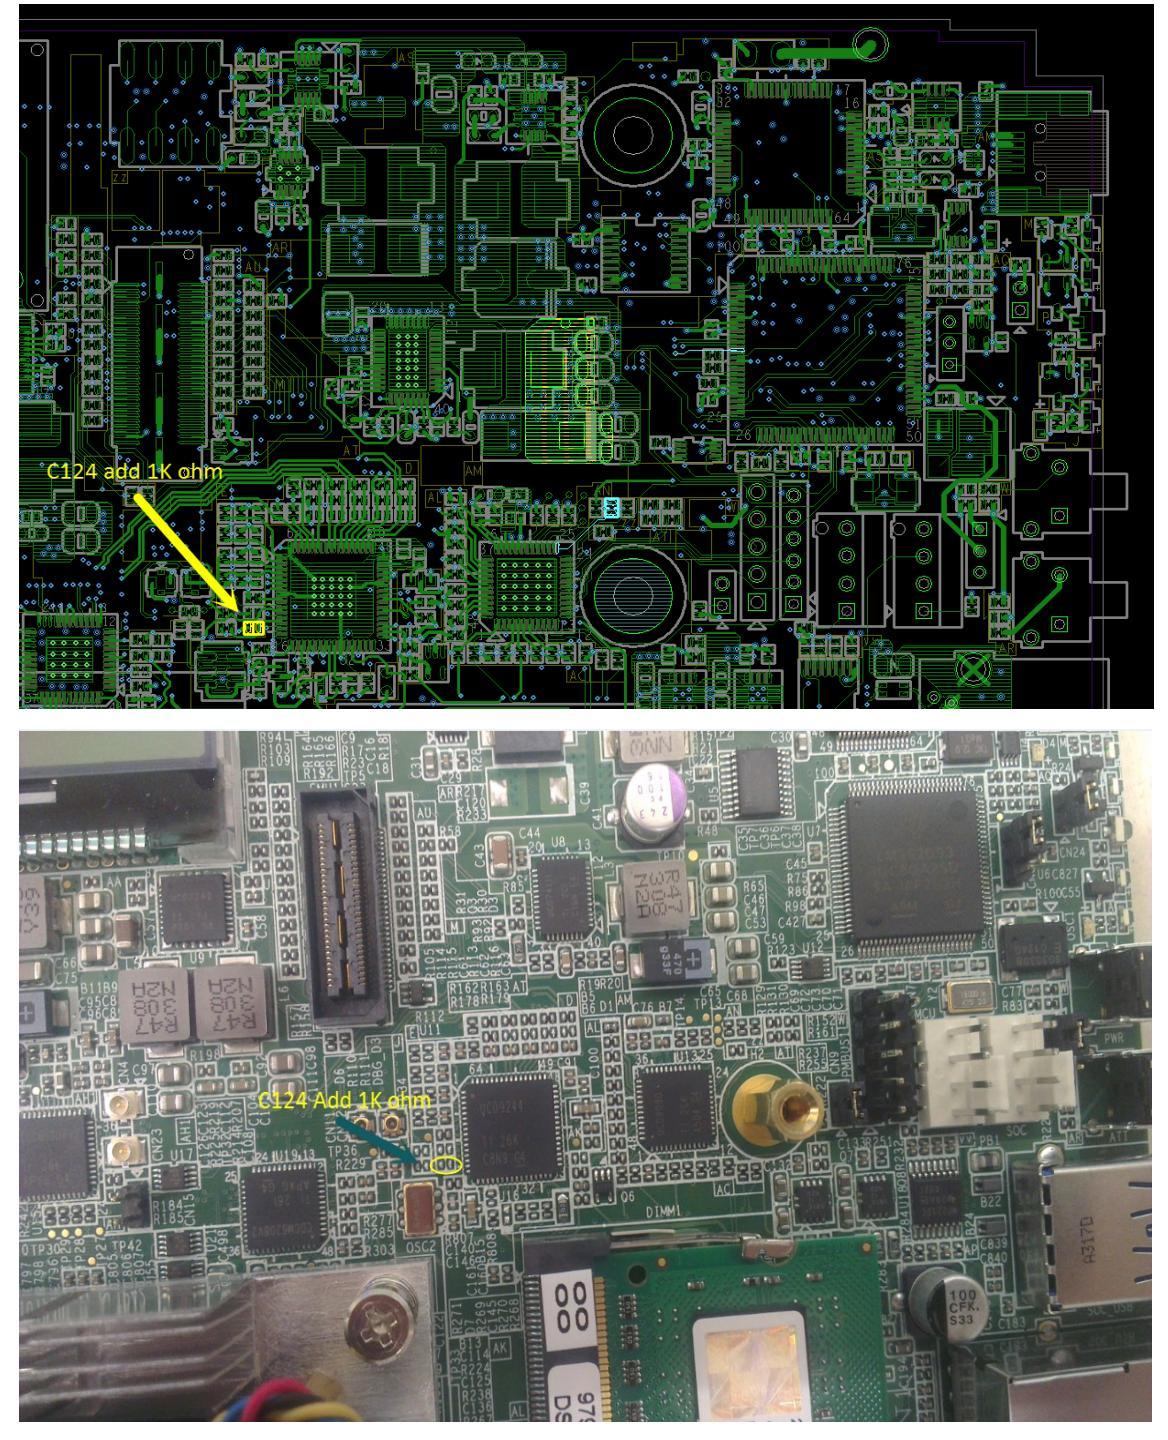
#### 4.3 SoC PWR stop on Power-up

- <u>Description</u>: UCD controller detects a fault during power-on and aborts the power-on sequence.
- <u>Workaround</u>: The fault comes from un-used CVDDT rail and FLT pin is floating. Adding a 1K ohm resistor on location C124 will pull-down the un-used FLT pin and avoid false fault signal.

Plans for a fix: The 1Kohm resistor is added before Rev 2.0 EVM shipping.

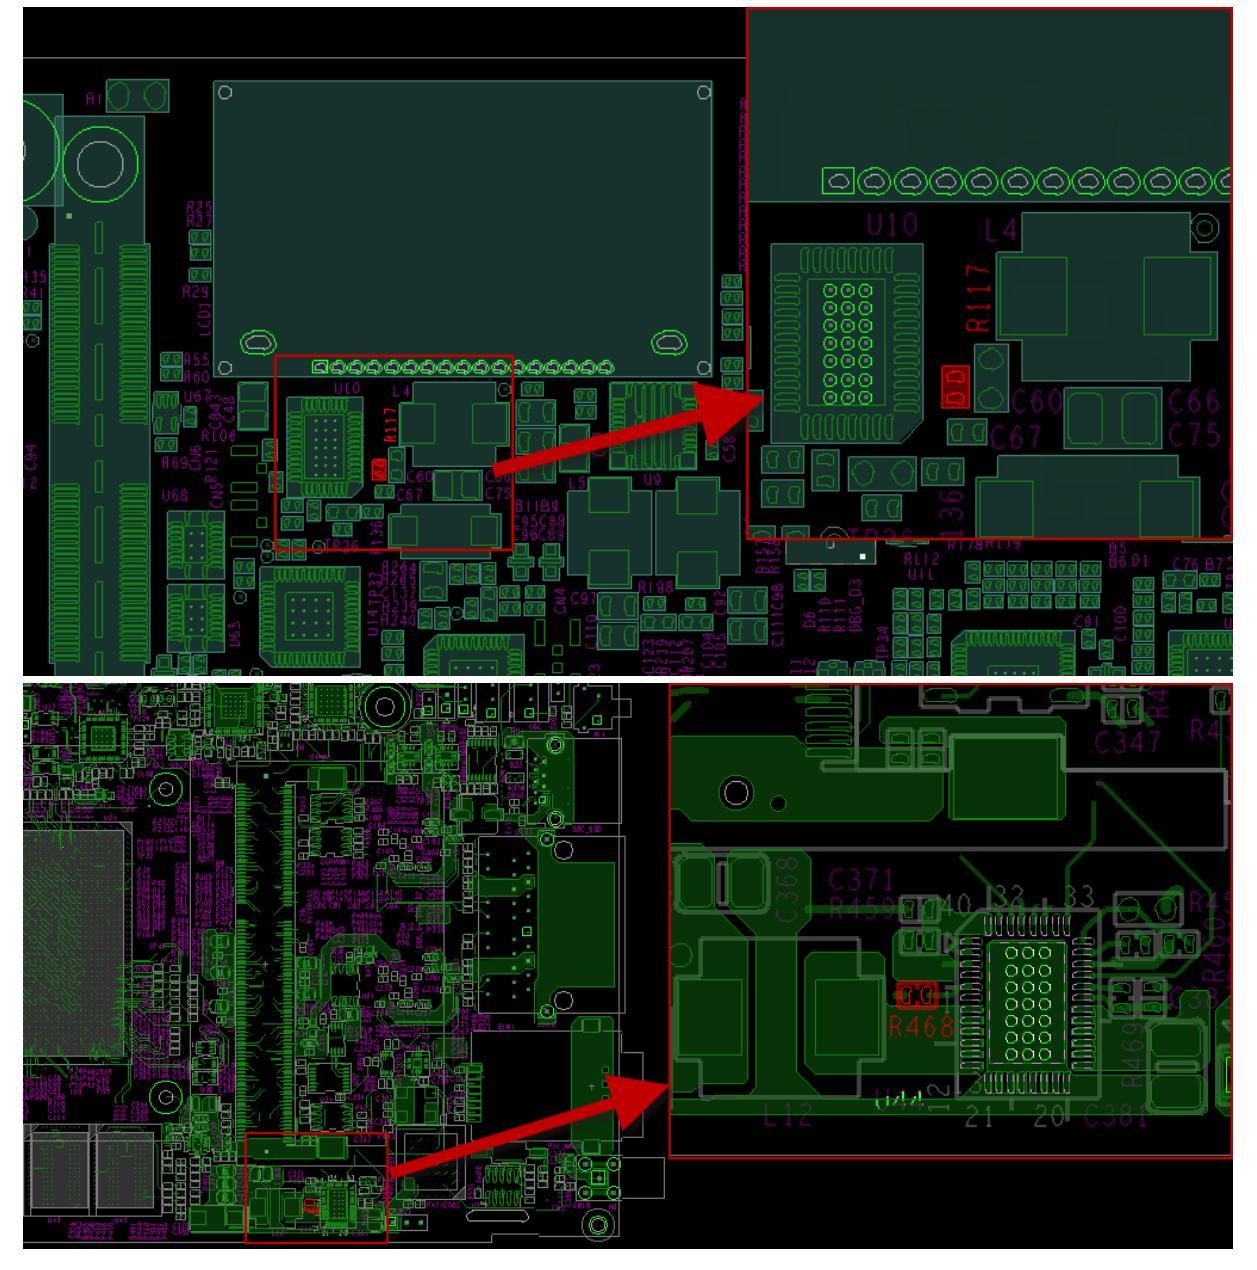
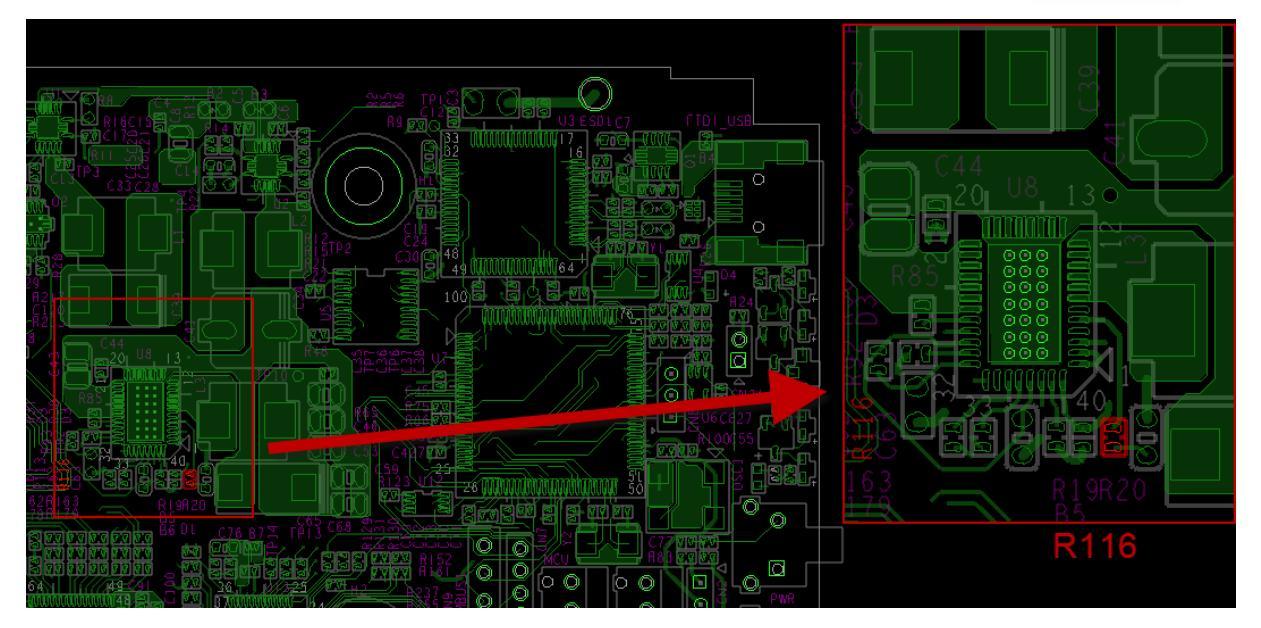
#### 4.4 Warning Messages in TFTP test on NAND Flash

- <u>Description</u>: When performing TFTP test on NAND in Linux, there are warning messages frequently. The symptom is related to power phase noise coupling on EMIF signals. Increasing boot resistor value could mitigate the issue but won't solve the issue completely.
- Workaround:
  - 1. Change R117 from 0 ohm to 10 ohm (boot resistor for CVDD/U10/UCD74120)
  - 2. Change R468 from 0 ohm to 10 ohm (boot resistor for CVDD/U44/UCD74120)
  - 3. Change R116 from 0 ohm to 10 ohm (boot resistor for VCC1V5/U8/UCD74111)

<u>Plans for a fix:</u> This issue is found in Rev 3.0 and it will also affect Rev 2.0 EVM. The resistor value change will be installed on all Rev 3.1 board before shipping. Root causes are still under investigation.

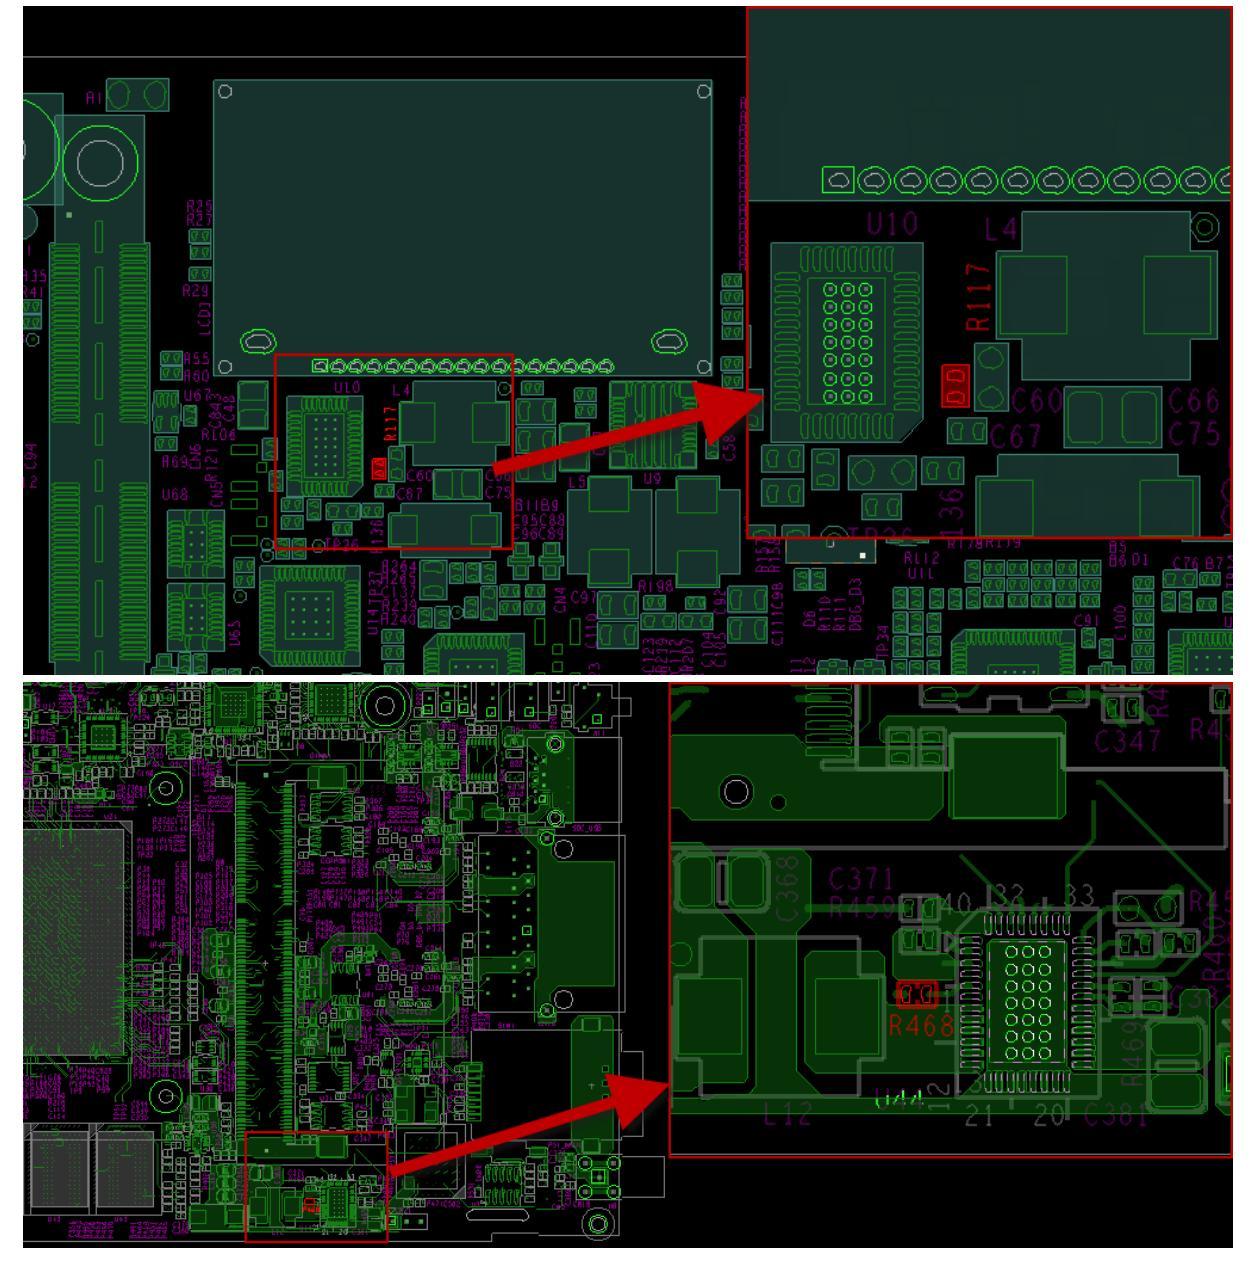
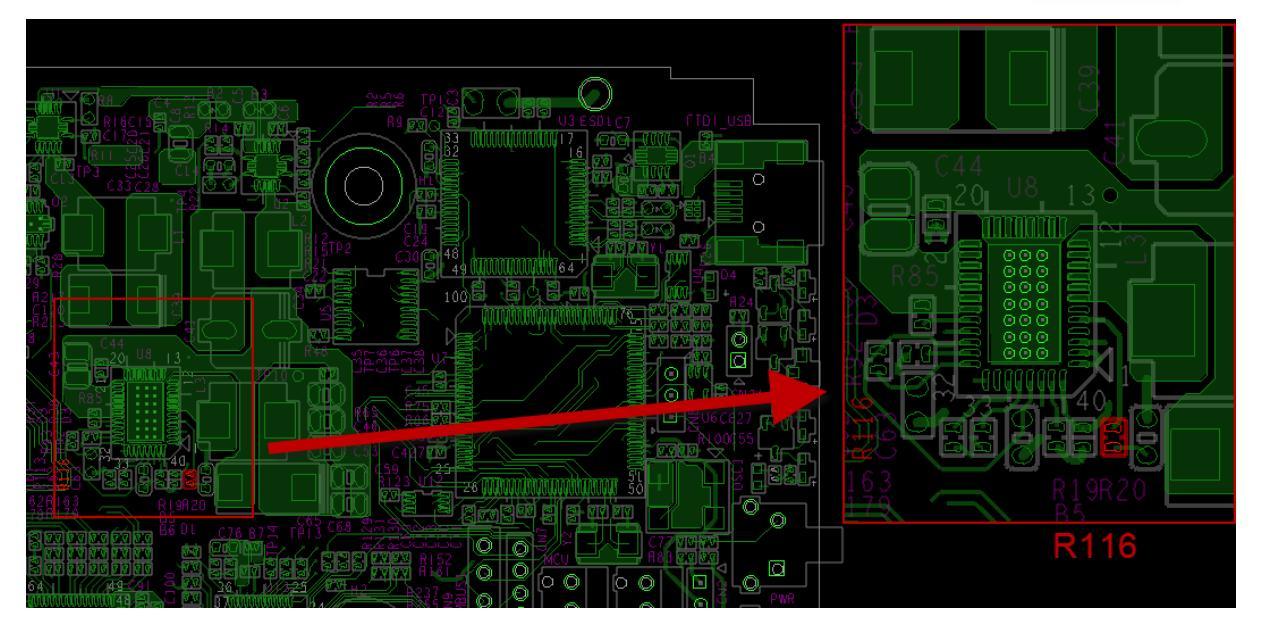
#### 6.1 Warning Messages in TFTP test on NAND Flash

- <u>Description</u>: When performing TFTP test on NAND in Linux, there are warning messages frequently. The symptom is related to power phase noise coupling on EMIF signals. Increasing boot resistor value could mitigate the issue but won't solve the issue completely. (This is the same issue as 4.4.)
- Workaround:
  - 1. Change R117 from 0 ohm to 10 ohm (boot resistor for CVDD/U10/UCD74120)
  - 2. Change R468 from 0 ohm to 10 ohm (boot resistor for CVDD/U44/UCD74120)
  - 3. Change R116 from 0 ohm to 10 ohm (boot resistor for VCC1V5/U8/UCD74111)

<u>Plans for a fix:</u> The resistor value change will be installed on all Rev 3.1 board before shipping. Root causes are still under investigation.
