# EVMK2HX Known Issues

## 2. EVMK2HX Rev 1.1 Known Issues

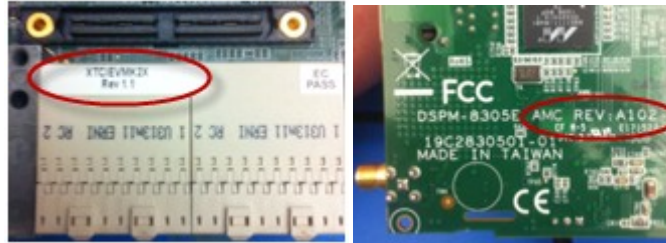
EVM Revision 1.1 could be identified by sticker on RTM Connector, and the PCB Revision is A102-1 and is located on bottom of board near GPS Antenna Input
